# BURGESS & NIPLE

330 Rush Alley | Suite 700 | Columbus, OH 43215 | 614.459.2050

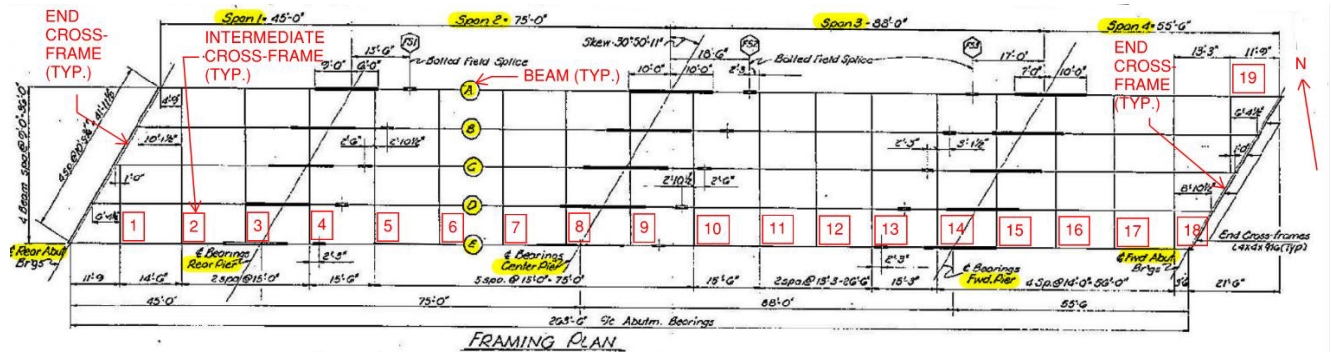
### RECOMMENDED ACTIONS/REPAIR ITEMS

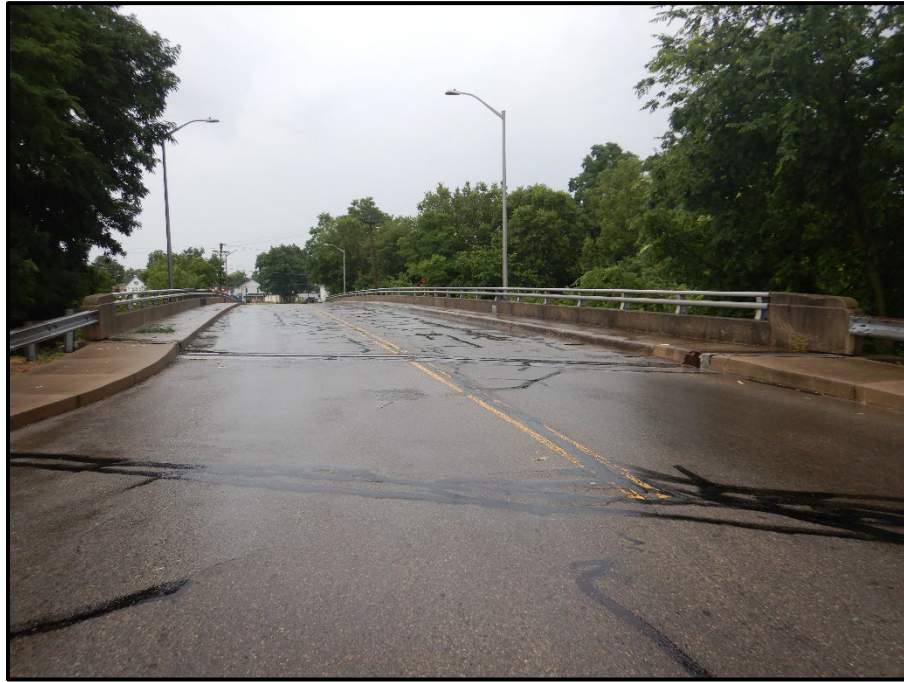
**Photo 1** – End view looking east.

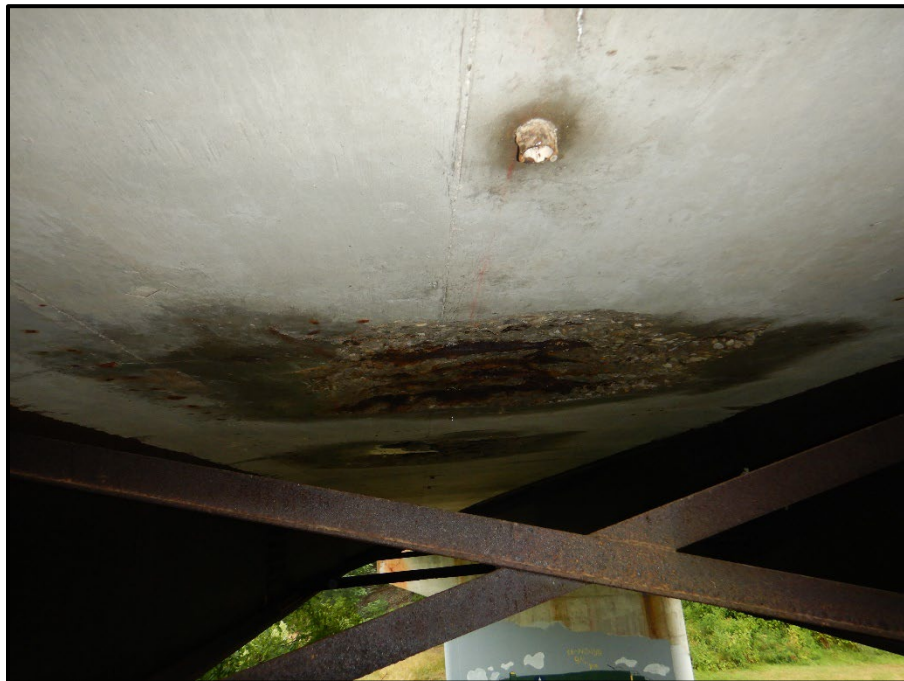
**Photo 4** – Looking west at the underside of the deck in span 3 bay 4 near the Center Pier. Note: two 5-foot x 5-foot spalls with exposed reinforcing steel in the underside of the deck.

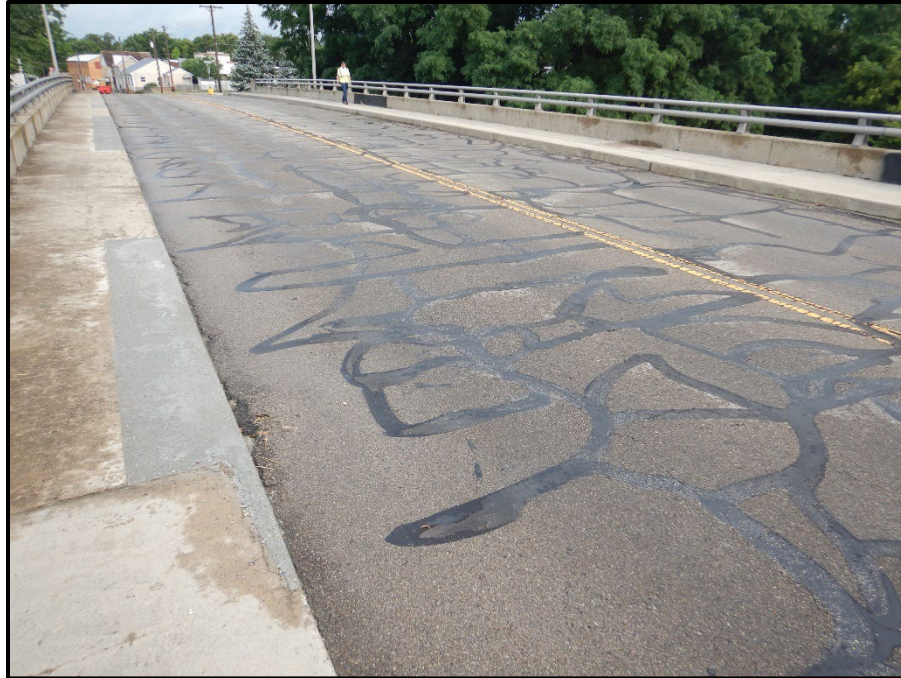
**Photo 5** – Looking northwest at the typical wearing surface in span 3.

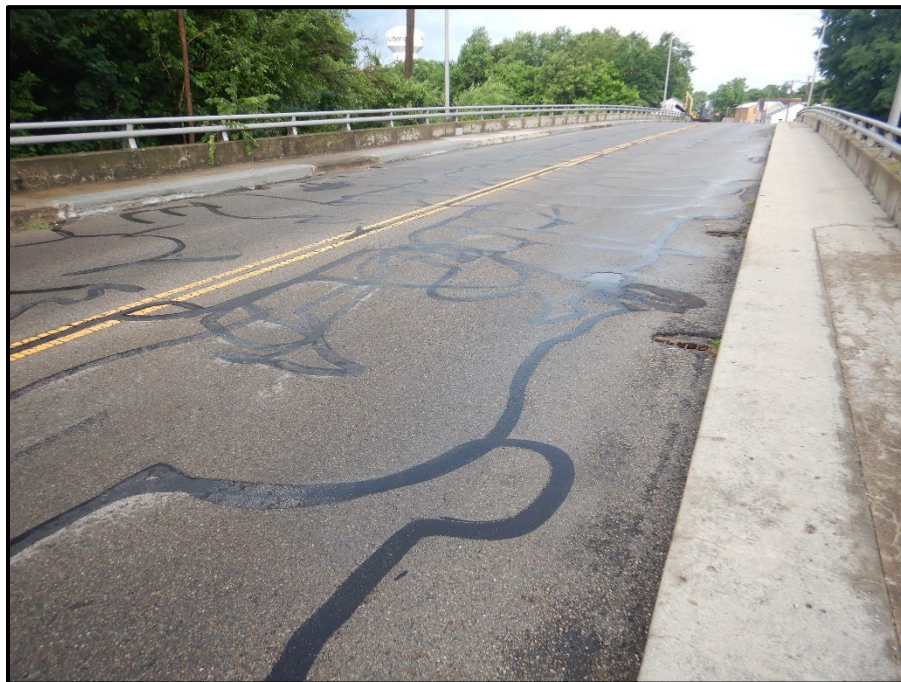
**Photo 6** – Looking southwest at the typical wearing surface condition in span 1. Note: sealed map cracking throughout. Multiple locations of concrete sidewalk repair throughout all spans.

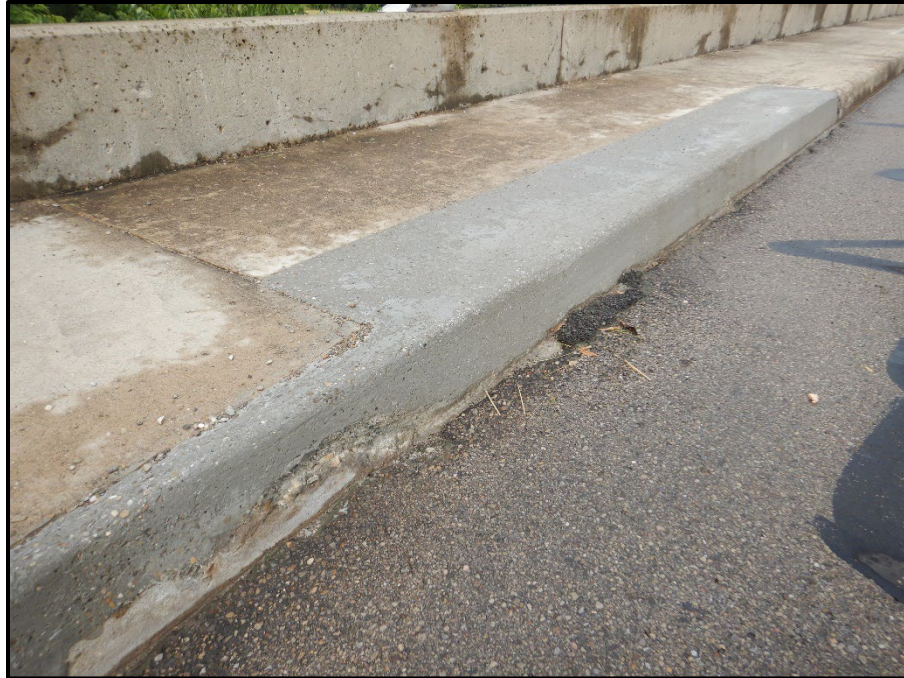
**Photo 7** – Looking south at the sidewalk repair in span 3.

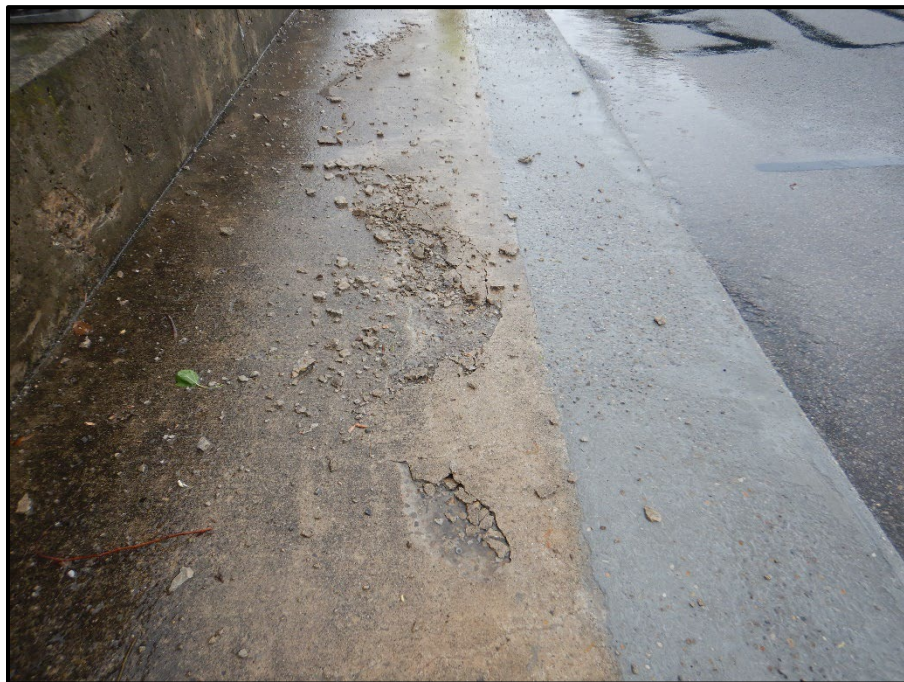
**Photo 8** – Looking west at the south sidewalk in span 3. Note: 7-foot-long section of the sidewalk is scaling.

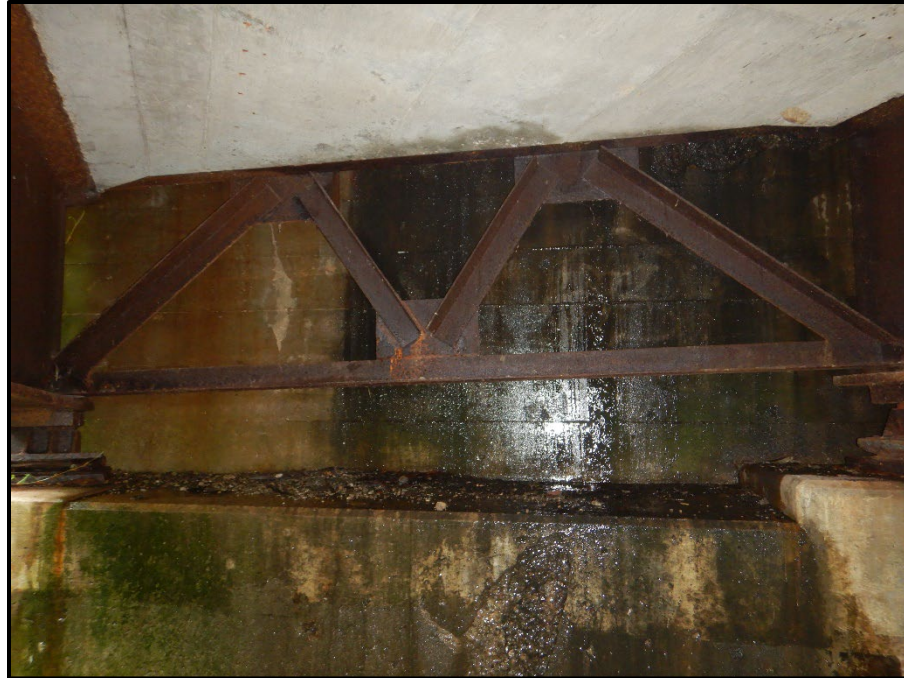
**Photo 13** – Looking east at the end cross-frame between beams A and B at the Forward Abutment. Note: heavy surface corrosion exists on the end cross-frames due to water infiltration through the deck joint.

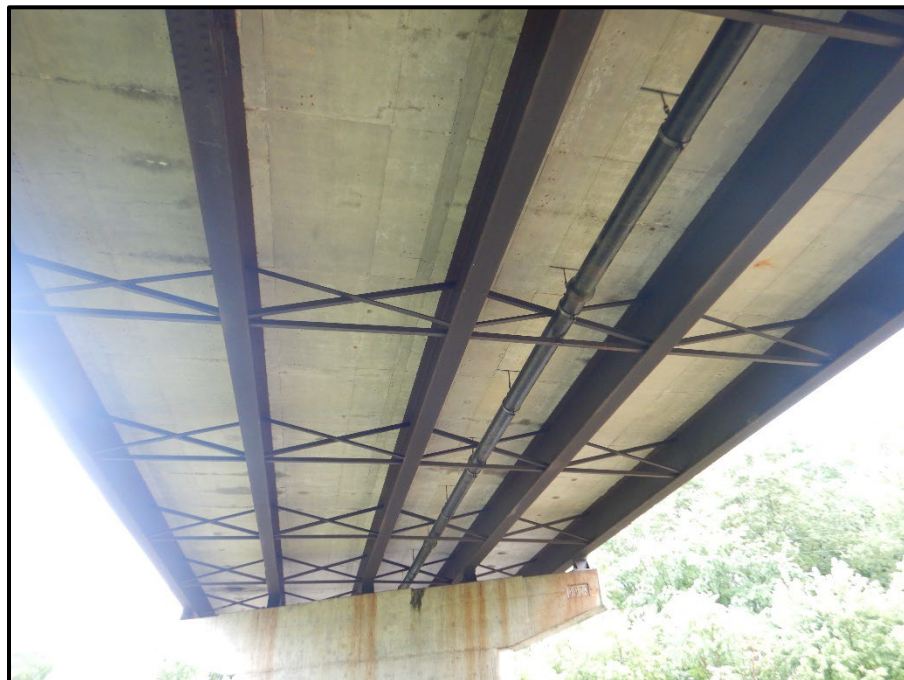
**Photo 14** – Looking east at the underside of span 2.

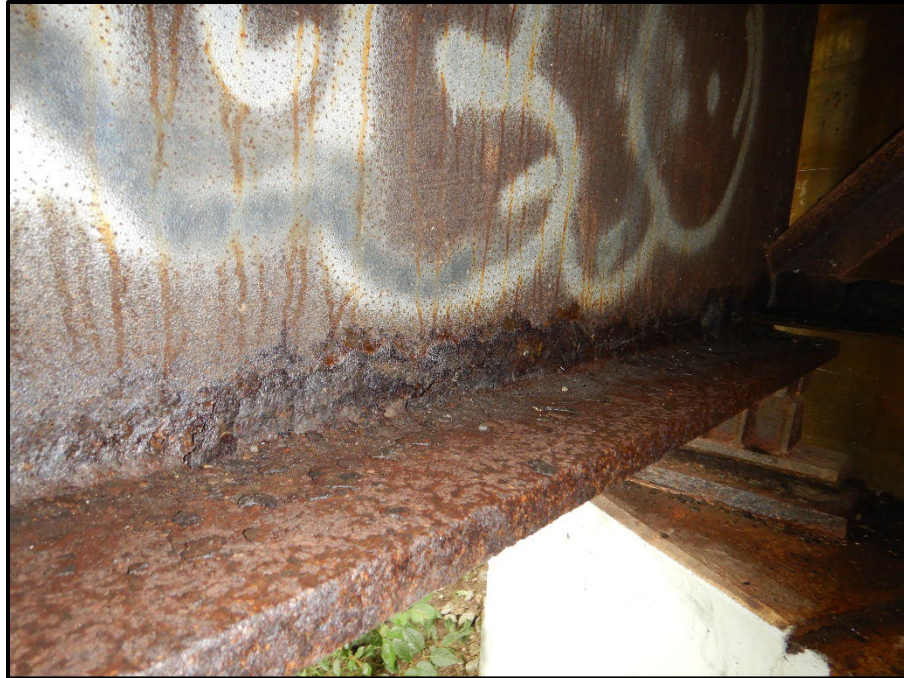
**Photo 15** – Looking southwest at span 1 beam E at the Rear Abutment. Note: laminar corrosion typical on the end 4 feet the steel beams at both abutments.

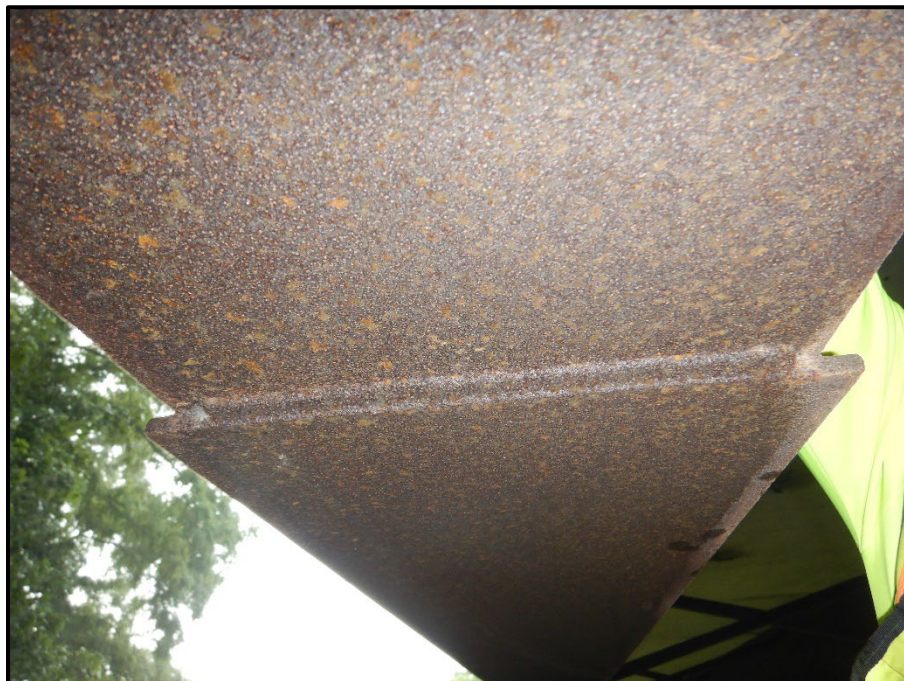
**Photo 16** – Looking east at the moment plate on the bottom flange of beam A in span 1.

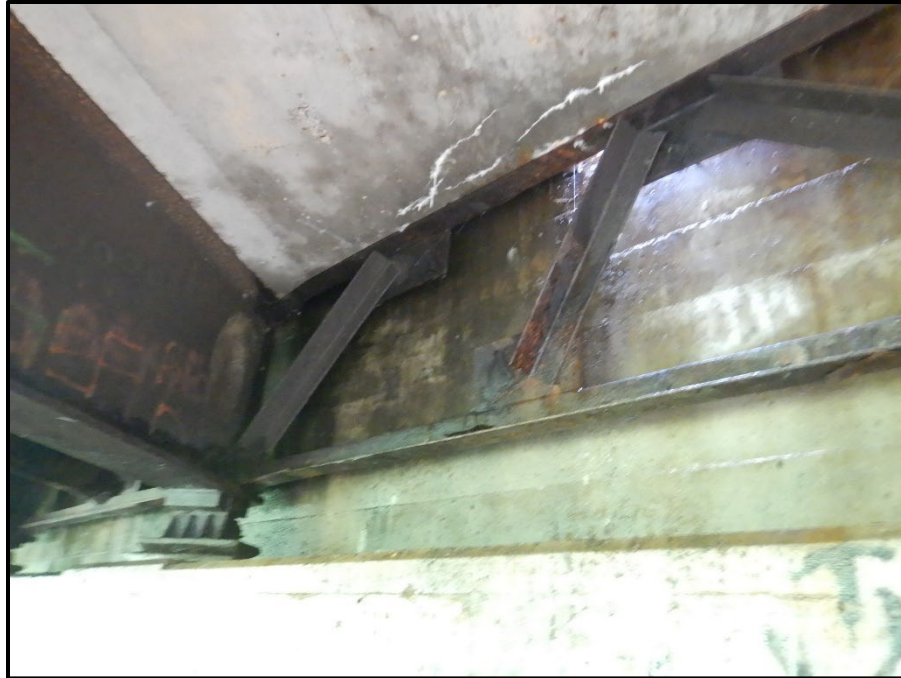
**Photo 19** – Looking east at the end cross-frame between beams D and E at the Forward Abutment. Note: missing diagonal angle.

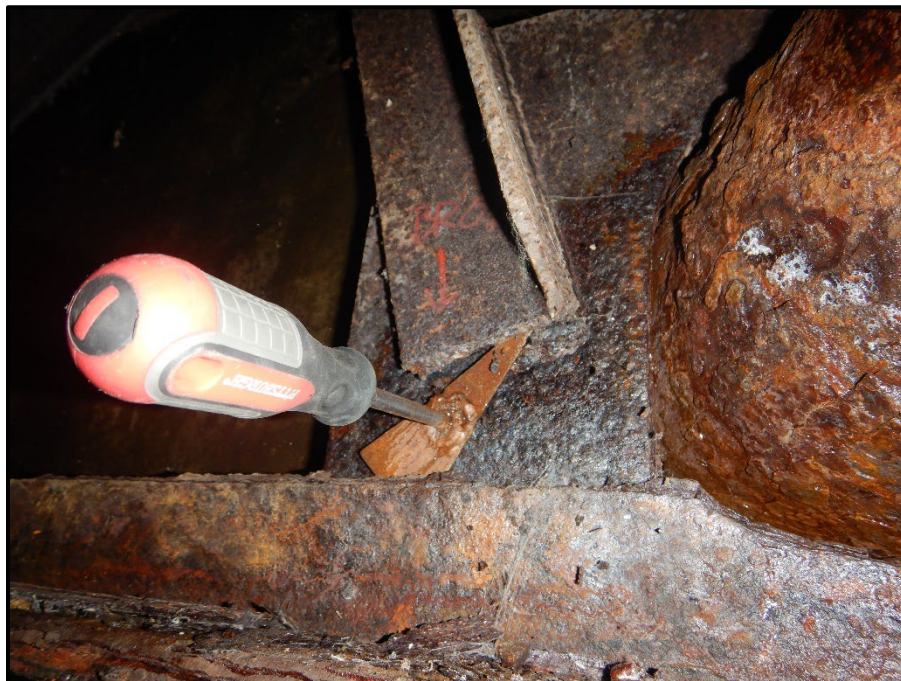
**Photo 20** – Looking east at the end cross-frame between beams C and D at the Forward Abutment. Note: broken diagonal angle weld.

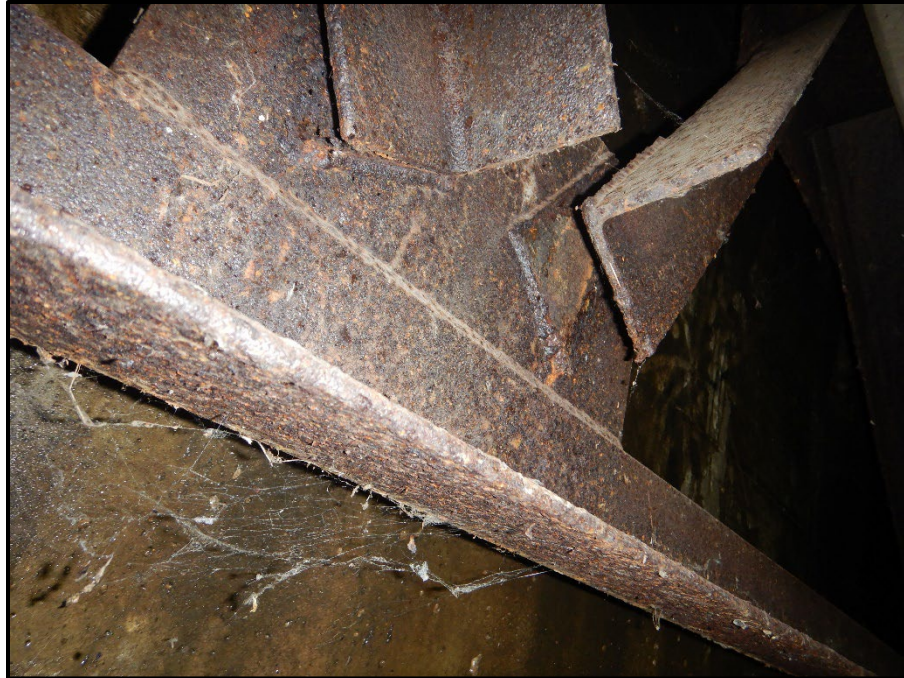
**Photo 21** – Looking east at the end cross-frame between beams B and C at the Forward Abutment. Note: broken diagonal angle weld.

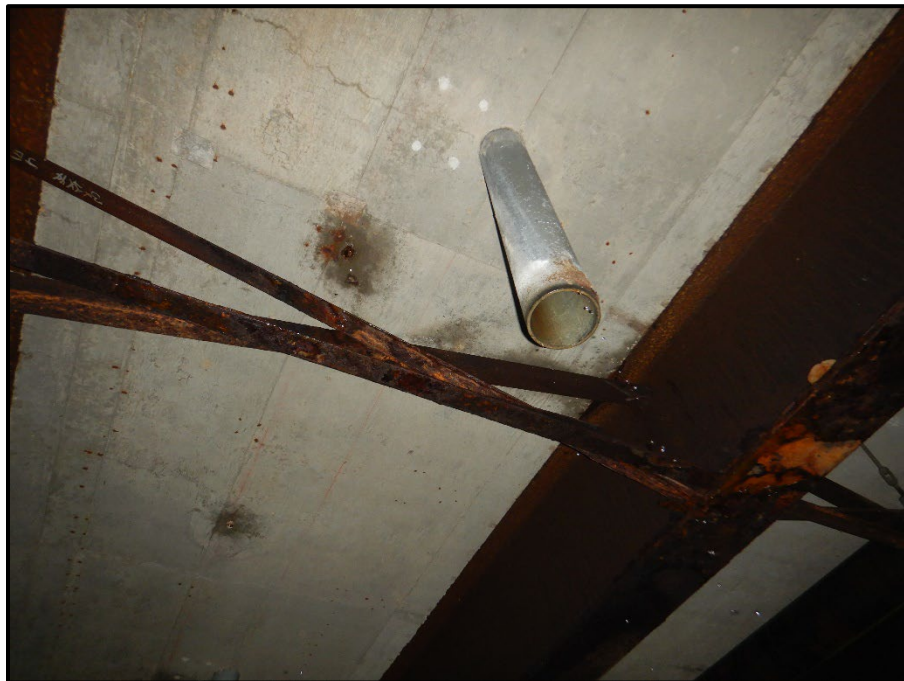
**Photo 22** – Looking west at the scupper drain and asphalt drain in span 4 between beams D and E at cross-frame 17. Note: asphalt drain is directly over intermediate cross-frame and drainage flows onto diagonal member and down to the bottom flange of the beam.

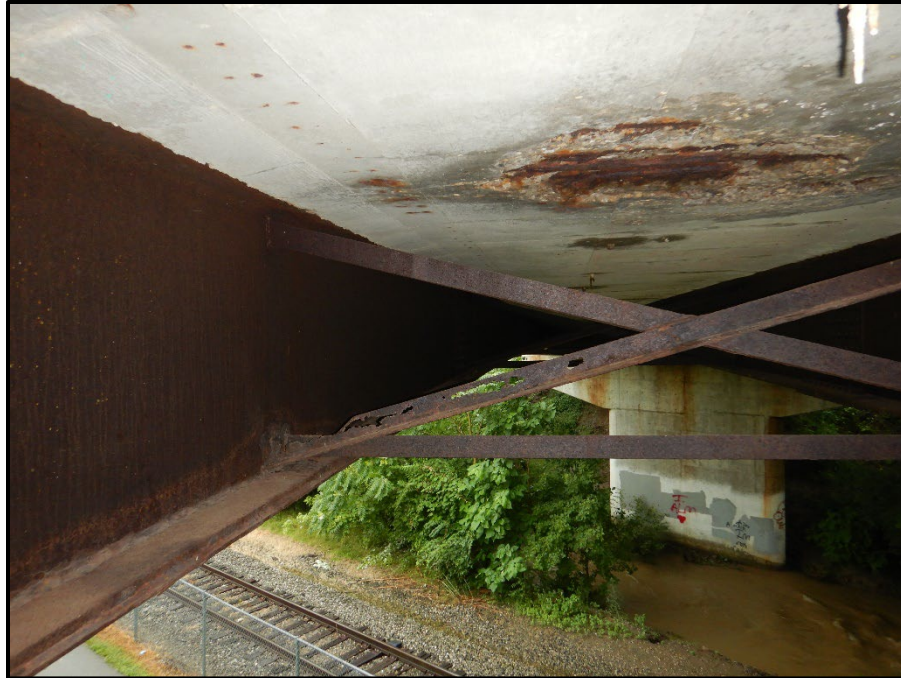
**Photo 23** – Looking at span 3 intermediate cross-frame 10 between beams B and C near the Center Pier. Note: bottom of concrete deck spall and full depth corrosion holes exist in the cross-frame diagonal due to flow from the asphalt drain.

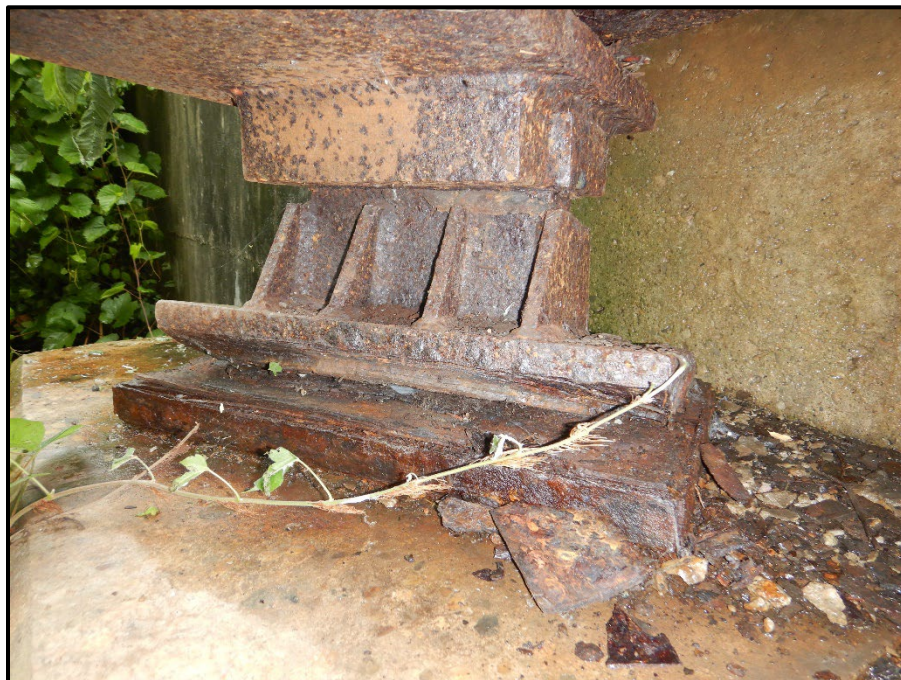
**Photo 24** – Looking north at the rocker bearing under beam A at the Forward Abutment. Note: laminar corrosion exists to the masonry plate due to a leaking expansion joint.

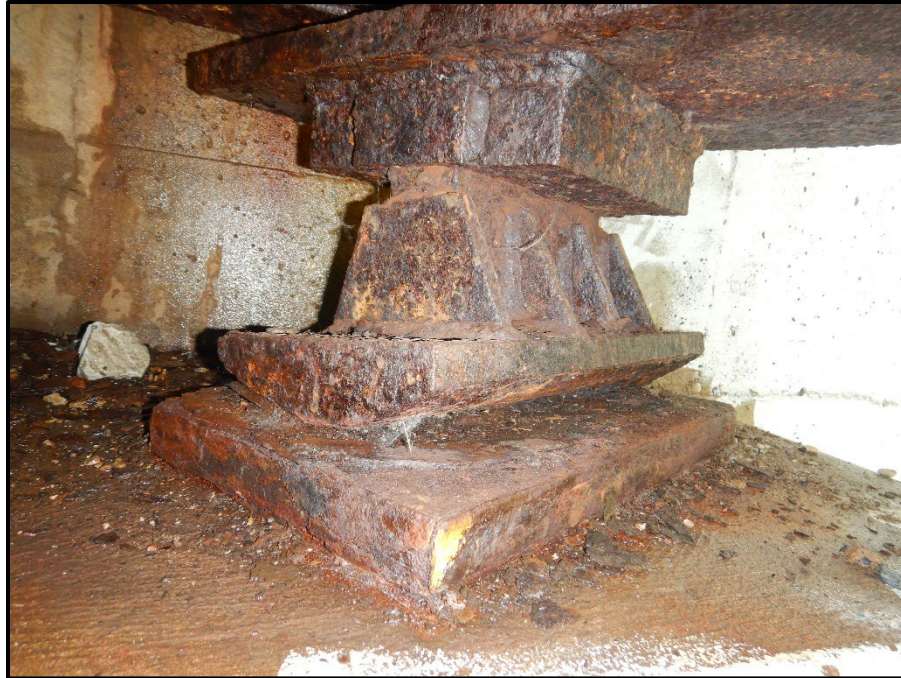
**Photo 25** – Looking northwest at the beam A rocker bearing at the Rear Abutment. Note: laminar corrosion with up to 1/8 inch loss to the masonry plate and bearing interface.

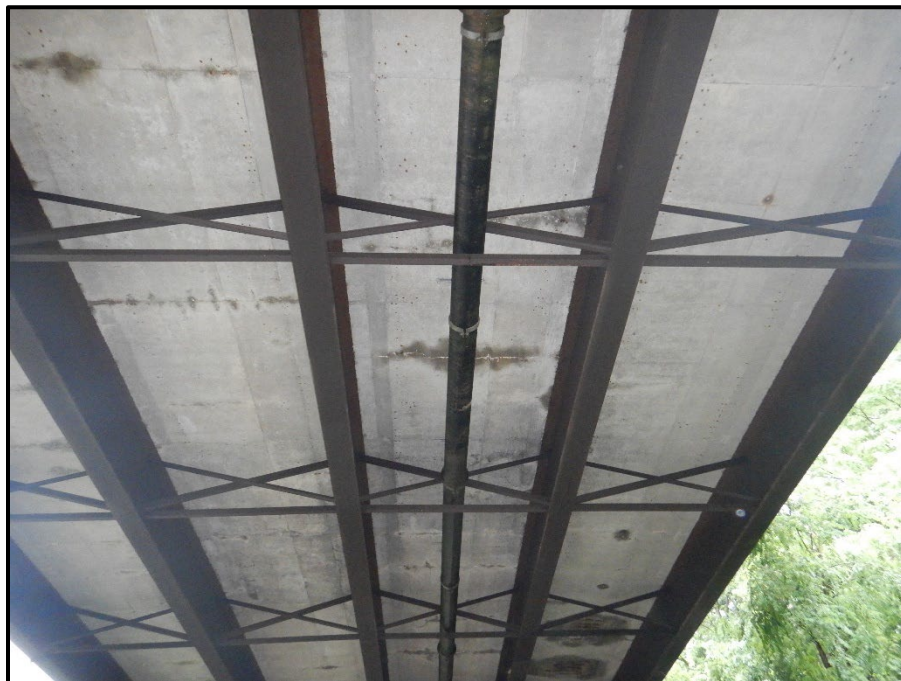
**Photo 26** – Looking east at the water pipe running between beams C and D.

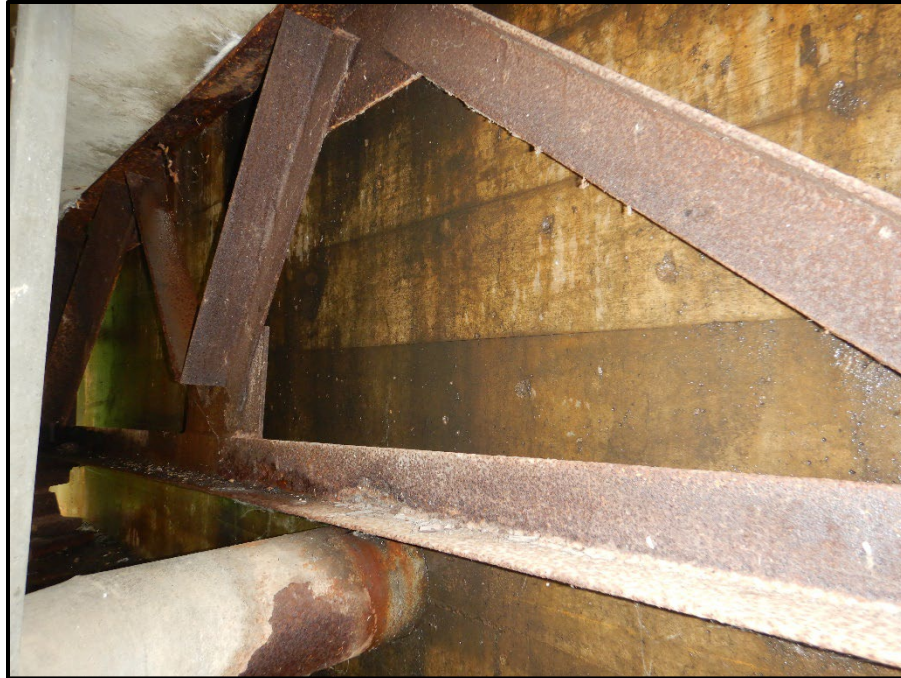
**Photo 27** – Looking southwest at the water staining and cracking in the Rear Abutment backwall.

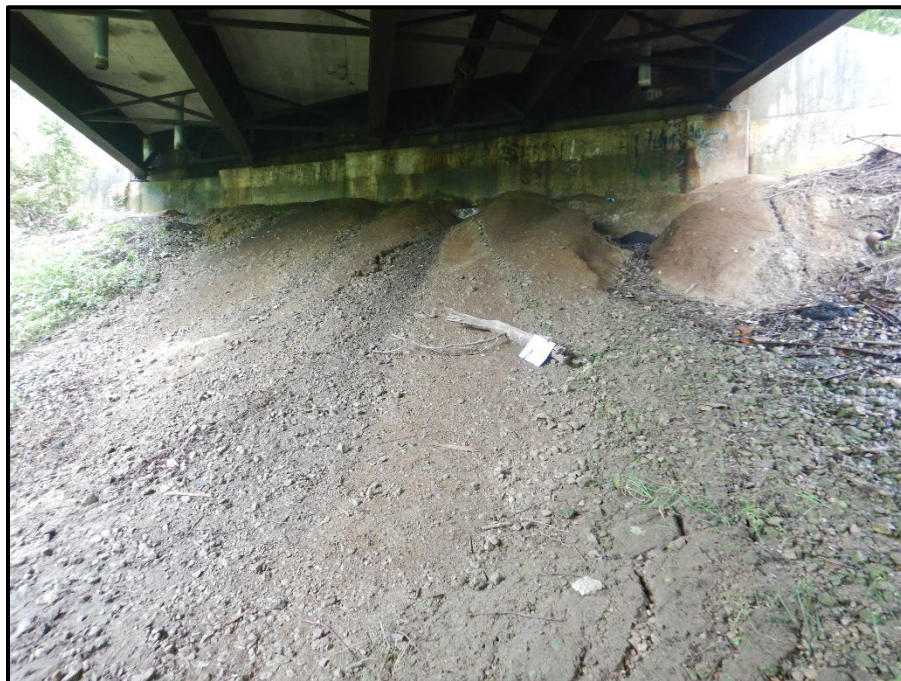
**Photo 28** – Looking east at multiple erosion ditches formed by scupper drainage in embankment in front of the Forward Abutment. Similar conditions are present at the Rear Abutment embankment.

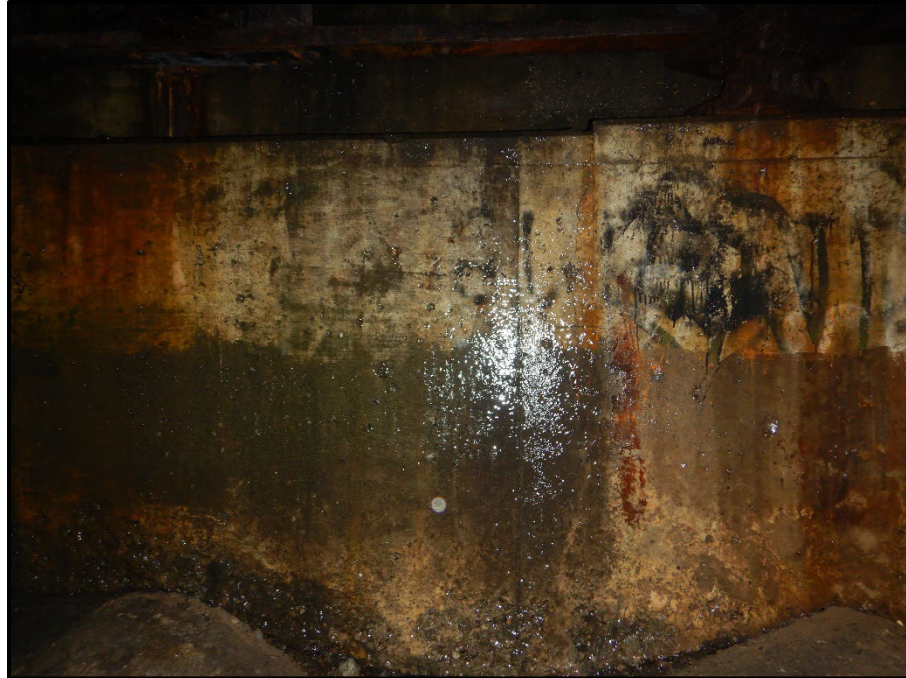
**Photo 29** – Looking east at active water leakage down the Forward Abutment backwall.

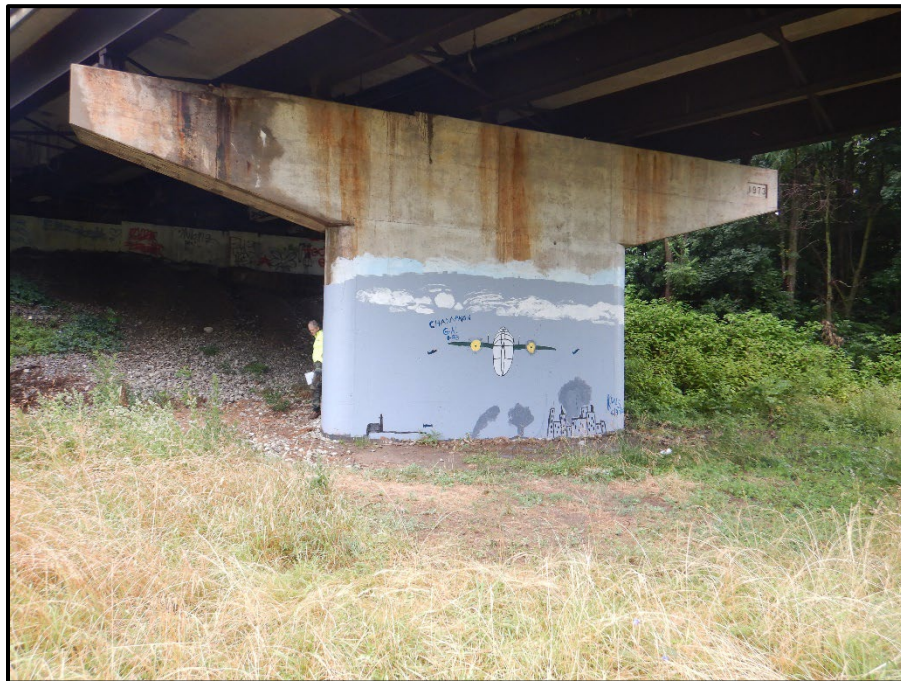
**Photo 30** – Looking west at the elevation view of the Rear Pier.

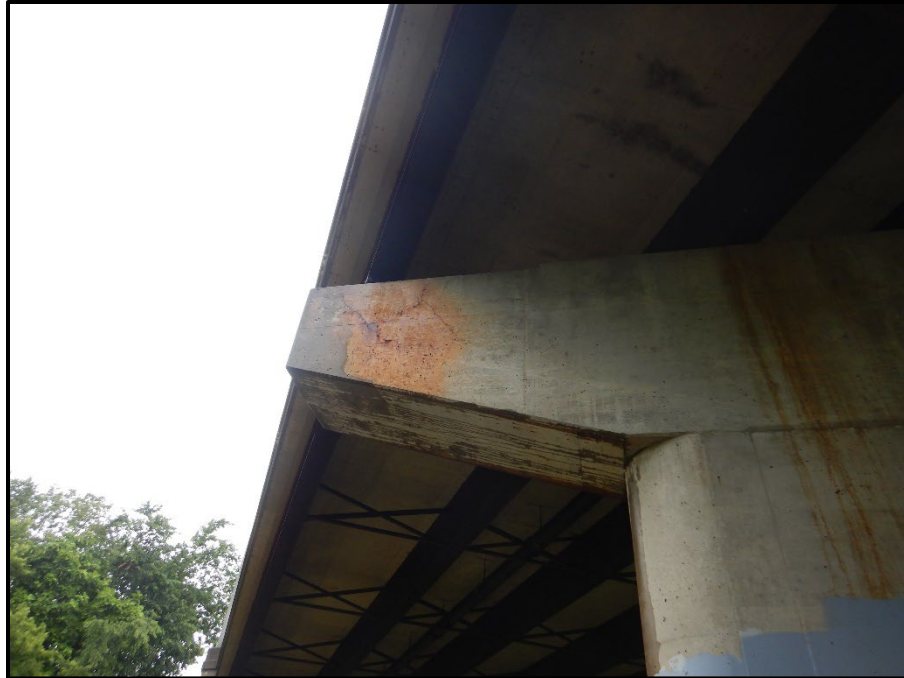
**Photo 31** – Looking west at the south end, east face of the Center Pier cap. Note: multiple shear cracks emanating from the beam E bearing.

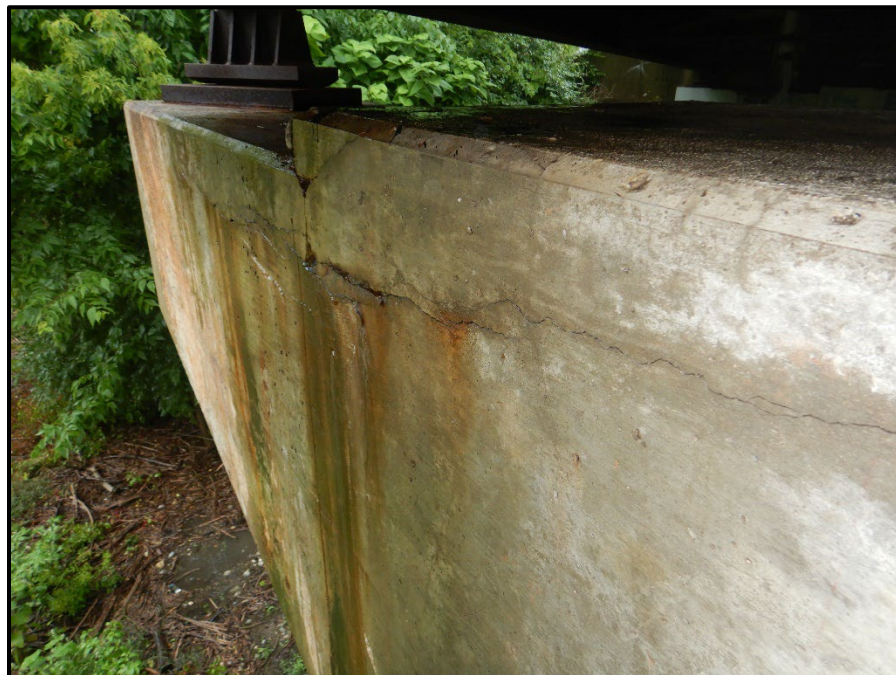
**Photo 32** – Looking south at the south end, east face top corner of the Rear Pier between beams D and E. Note: 2-foot-wide x 4-foot-long x 16-inch-tall delamination caused by asphalt drain located directly above the cap.

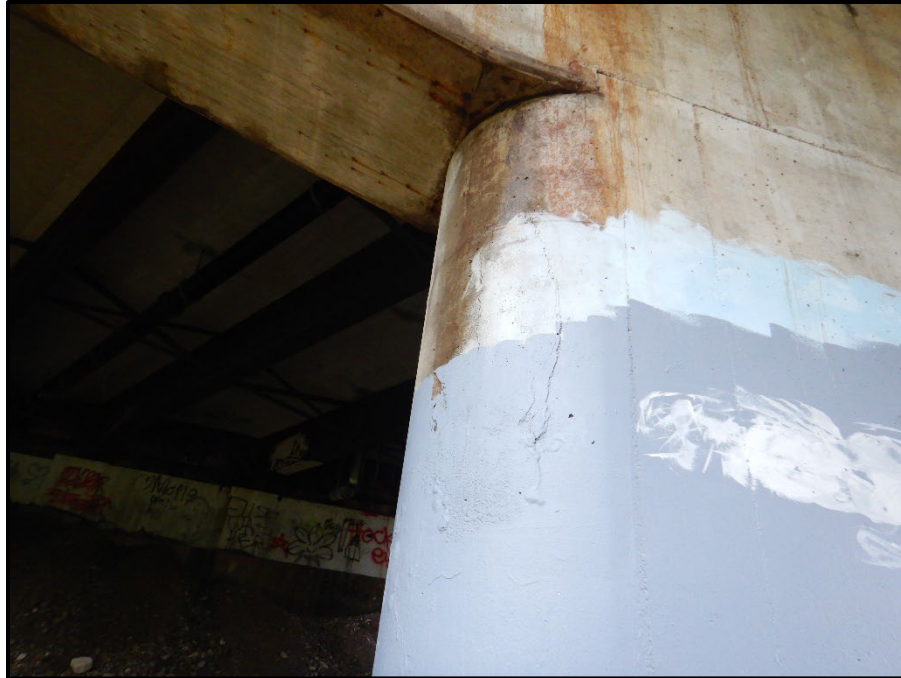
**Photo 33** – Looking west at the south end of the Rear Pier wall. Note: 4-foot-tall x 2-foot-wide delamination caused by an asphalt drain discharging onto the top of the pier cap.

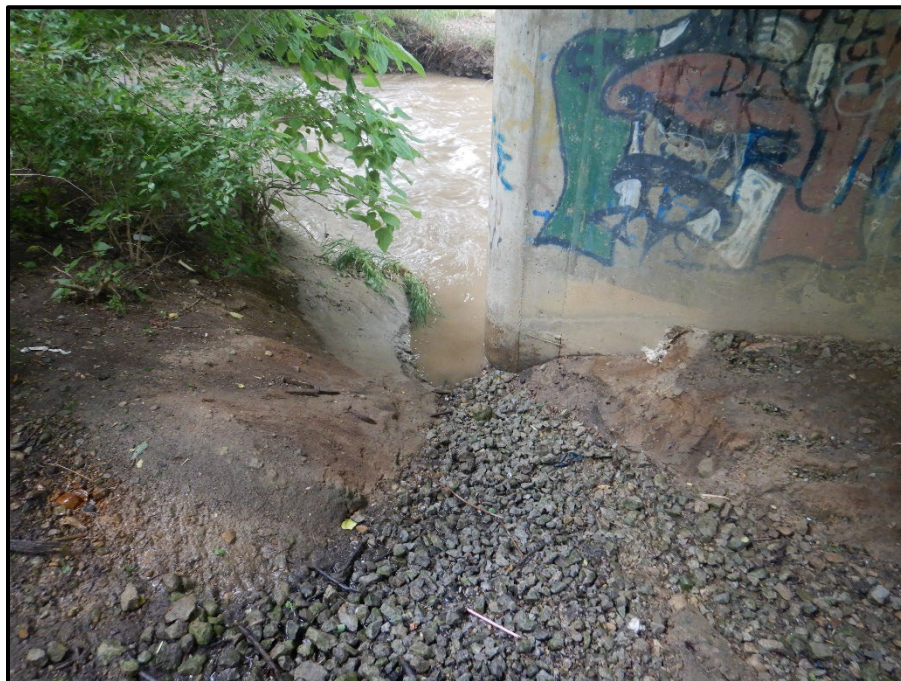
**Photo 34** – Looking west at the scour hole at the end of an erosion ditch at the south end of the Forward Pier.

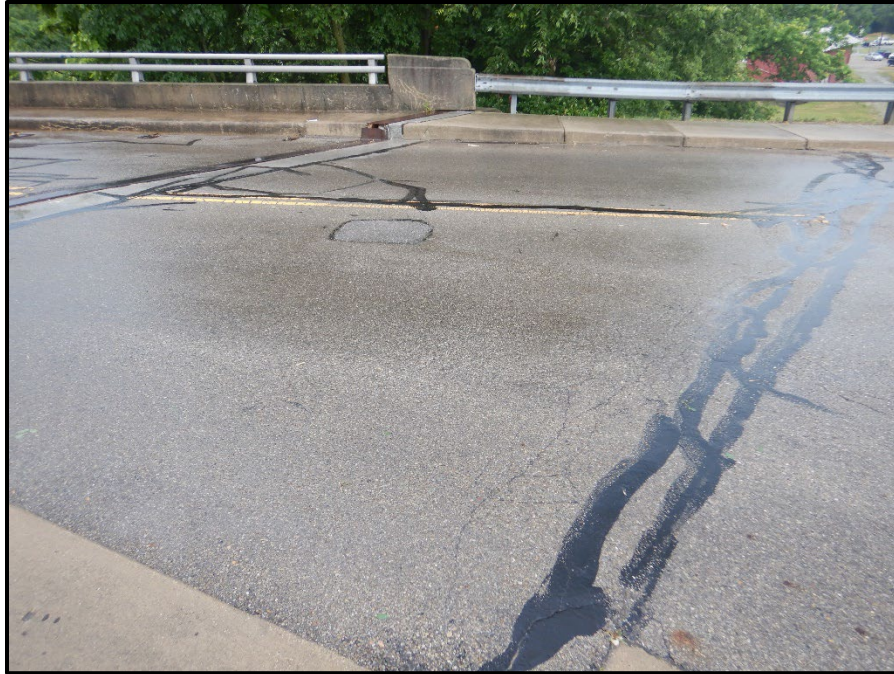
**Photo 35** – Looking south at the west approach roadway. Note: multiple sealed transverse and longitudinal cracks in the approach roadway.

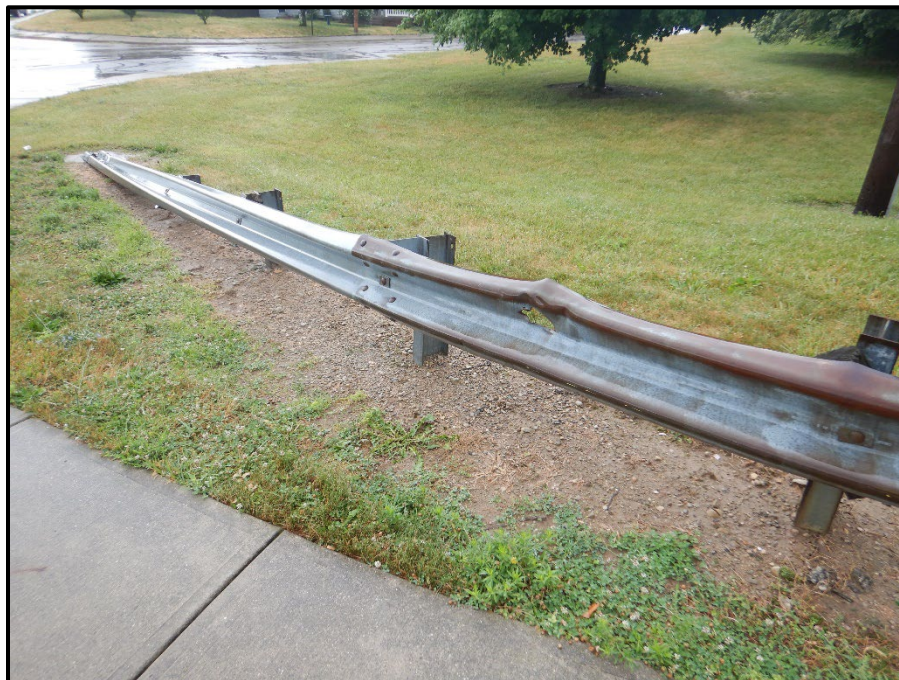
**Photo 36** – Looking northwest at the northwest approach guardrail. Note: turn down end treatment.

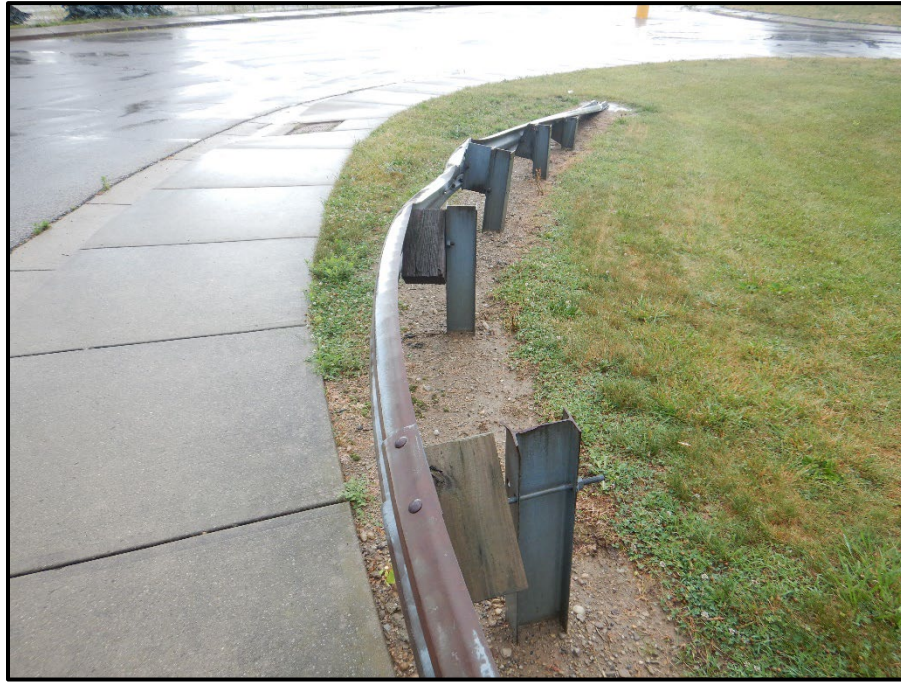
**Photo 37** – Looking west at the northwest approach guardrail. Note: 5-foot-long section of impact damaged guardrail and multiple twisted and loose timber block outs.

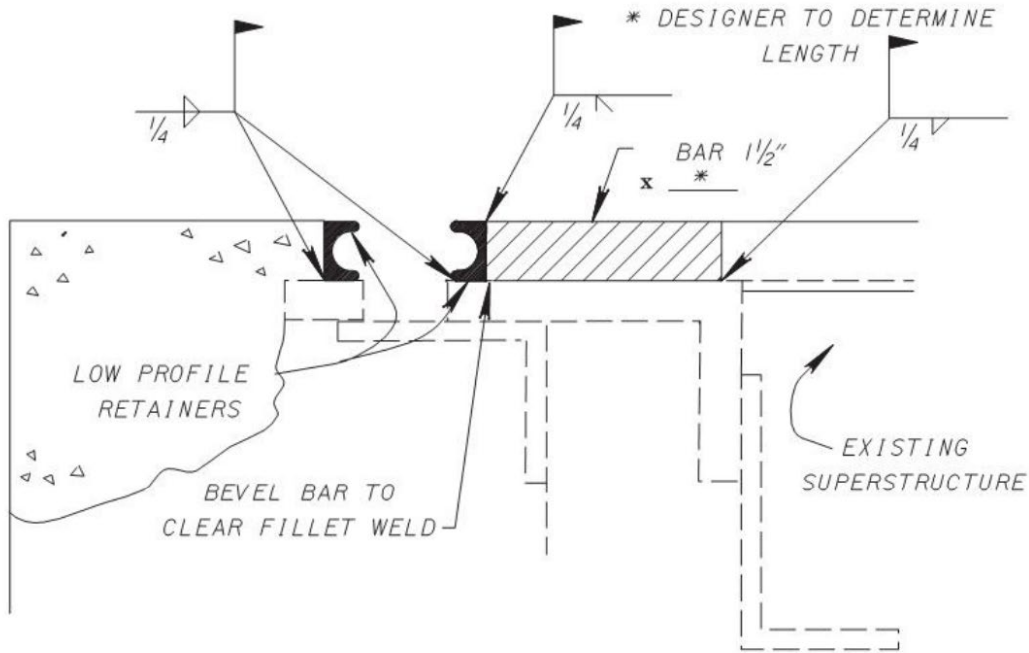
VERTICAL EXTENSION OF STRUCTURAL  
EXPANSION JOINTS  
INCLUDING ELASTOMERIC STRIP SEALS
