To: Scott Schmid
Clark County-Springfield Transportation Coordinating Committee

August 13, 2021

From: Kendra Schenk, PE, PTOE, RSP₂₁
Brandon Totman, PE
Katie Coon, EI
Burgess & Niple, Inc.

Subject: South Main Street Safety Study

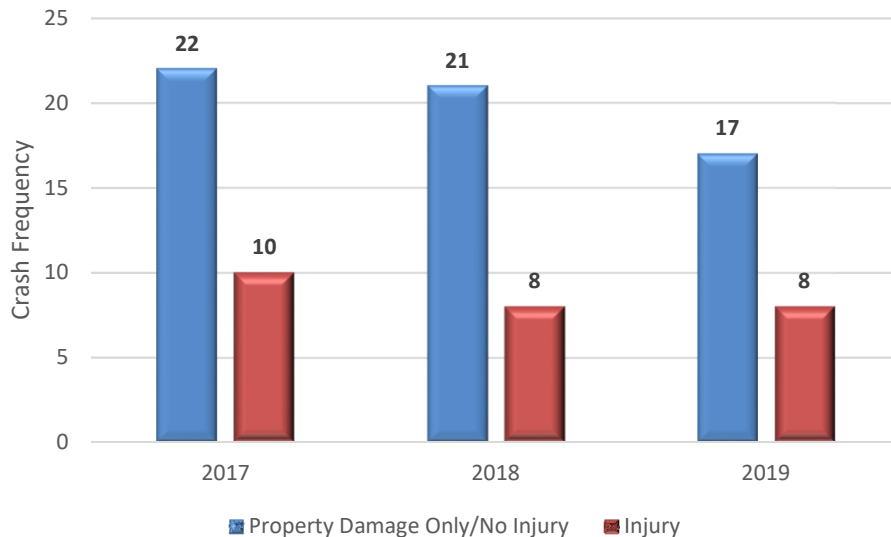
Figure 1: Crash Frequency by Severity

Crash data from January 1, 2017 through December 31, 2019 was obtained for the study area using ODOT's GIS Crash Analysis Tool (GCAT) and analyzed using the Crash Analysis Module (CAM) Tool. The crash reports were opened and reviewed to verify to location of the crash and the crash type. A collision diagram that shows crash patterns by illustrating the approximate location of each reported crash is provided in **Attachment 2**. The output for the CAM tool is provided in **Attachment 3**. There was a total of 86 crashes with 26 (30 percent) resulting in injury. Three serious injuries occurred in the study area. **Figure 1** shows the crash frequency by year and severity.

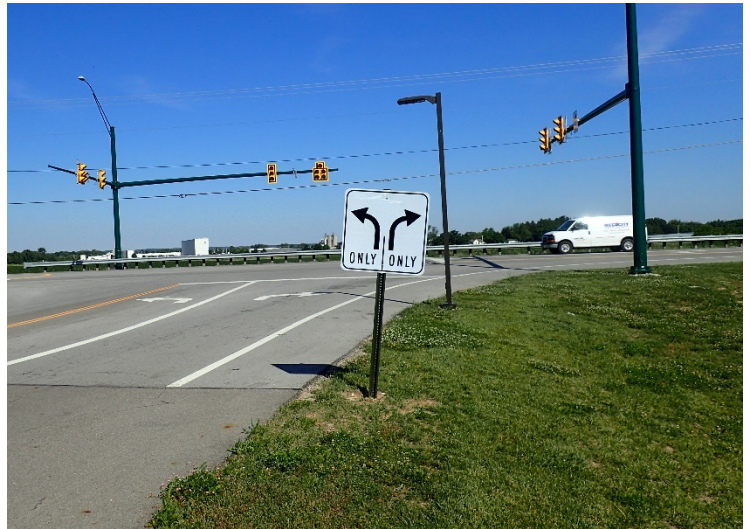
- Since construction, there have been three rear end collisions on the northbound and southbound approaches to the signal. These crashes could be attributed to the recent installation of the signal.
- During the site visit it was observed that the lane use sign on the eastern leg of the intersection was not mounted at the standard sign height. The current sign post is approximately four feet high, shown in **Photo 1**.

Photo 1: Improperly Mounted Lane Use Sign

- Re-erect existing lane use sign to standard height based on ODOT Standard Construction Drawing 42.20.

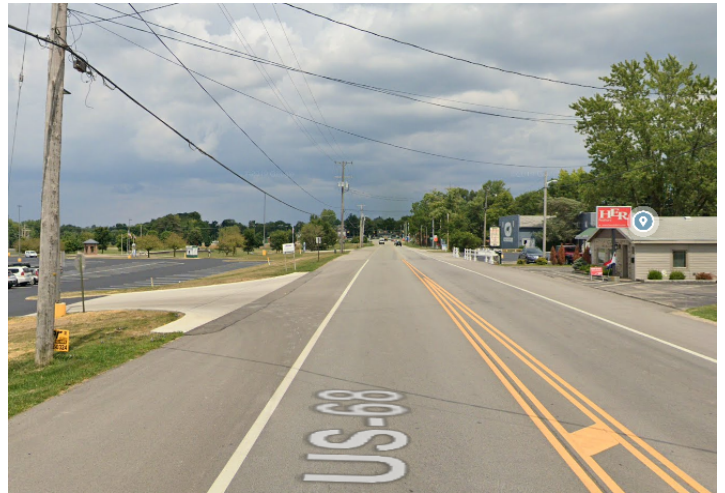
- Four rear end collisions occurred at the driveway to the Champaign County Building likely as a result of vehicles slowing or stopping in the through lane to turn left. The driveway is shown in **Photo 2**.
- Backing, fixed object and rear end collisions occurred along this section of South Main Street, likely due to the prevalent number of driveways and local roadway intersections.
- During the site visit the school crossing pedestrian sign was leaning and not mounted at the standard sign height, shown in **Photo 3**.

Photo 2: Driveway to Community Building

- Install a two-way left-turn lane (TWLTL) from the Urbana Elementary/Junior High School Driveway to Lewis B Moore Drive (SR 55). This may require shoulder reconstruction and re-grading of the surrounding ditches (**Photo 4**). The provided information does not indicate if the shoulders are full-depth to accommodate traffic with the reallocation of the pavement.
- Re-erect existing school crossing pedestrian sign to standard height based on ODOT Standard Construction Drawing 42.20.

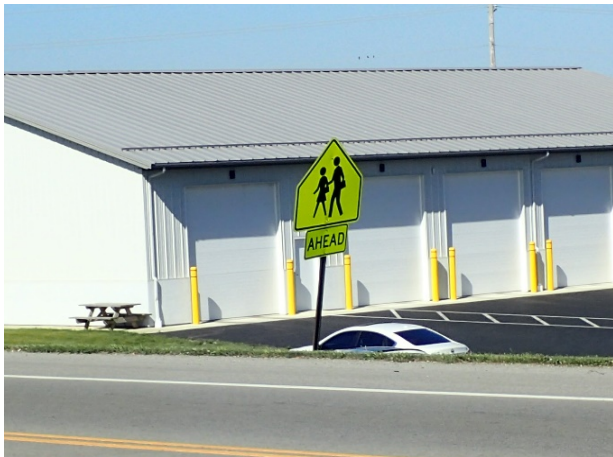
Photo 3: Improperly Mounted Sign

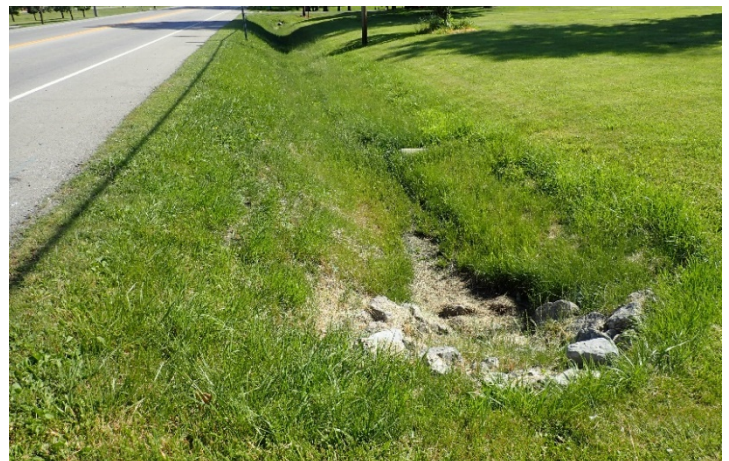
Photo 4: Ditch North of Pearce Place

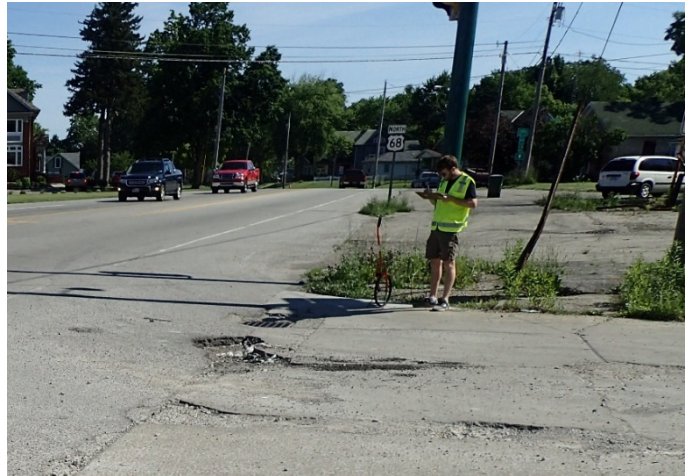
- During the field visit, it was observed that the northbound protected left-turn signal phase was called when there were no vehicles present.
- The pavement at the signalized gas station driveway has deteriorated, shown in **Photo 5**, making it difficult to traverse for some vehicles.
- Rear end crashes occurred on the eastbound and westbound approaches of the intersection, likely due to driver inattention to slowing or stopped turning traffic.

Photo 5: Deteriorated Gas Station Driveway

- Repair the pavement on the gas station driveway. The City of Urbana is planning improvements for the sidewalk on the east side of the intersection that would require the replacement of the driveway by the property owner. The cost of replacing this drive will not be included in the cost estimate.

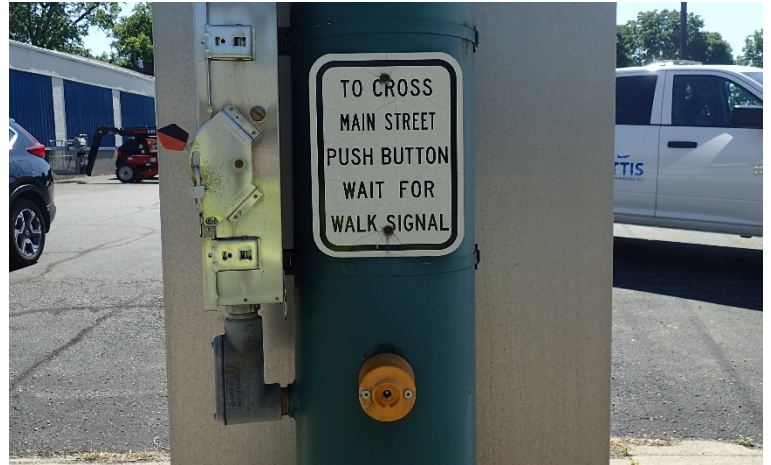
- During the field visit, it was found that both pedestrian push buttons were damaged, shown in **Photo 6**.
- A utility line obstructed the westbound signal head, shown in **Photo 7**.
- A pedestrian on a mobility scooter was observed riding through the intersection during the field visit, shown in **Photo 8**.
- It was observed that vehicles traveling northbound had difficulty turning right onto E Powell Avenue due to the tight radius of the curb. One fixed object occurred when a large vehicle was turning right and hit a pole on the southeast corner of the intersection.
- Four rear end collisions occurred on northern leg of intersection.

Photo 6: Damaged Pushbutton

- Introduce split-phasing on eastbound and westbound approaches to eliminate left-turn path overlap (see below for results from the traffic analysis).
- Add a southbound left-turn lane onto E Powell Avenue. Adding this turn lane would take away approximately 220 feet of parking, or eight parking spaces.
- Add “LEFT TURN YIELD ON GREEN” on eastbound and westbound approaches to reinforce yielding procedures due to the offset intersection (this improvement is not necessary if the intersection is split-phased).
- The following improvements are proposed to improve safety but not as part of the resurfacing project:
 - Replace pedestrian push button faces.
 - Install backplates to improve signal visibility.

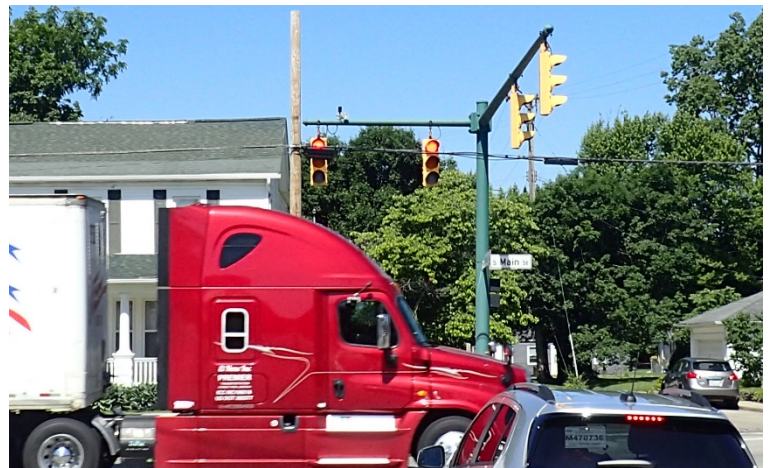
Photo 7: Obstructed Signal

- Adjust utility line to not interfere with signal head.
- A long-term improvement is to align E Powell Avenue with W Powell Avenue by relocating E Powell Avenue to the north into a vacant parking lot, illustrated on **Page 11**.
- Another long-term improvement is to increase the curb radius of the southeast corner, illustrated on **Page 12**.

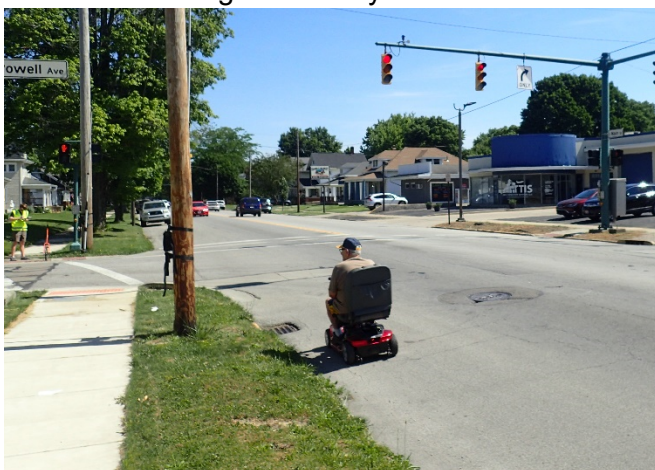
Photo 8: Pedestrian on Roadway

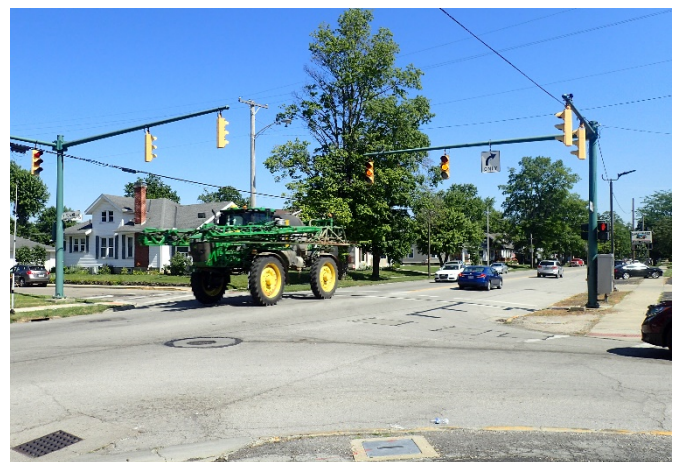
Photo 9: S Main St and Powell Ave

- One left-turn collision occurred between a southbound left-turning vehicle and a northbound left-turning vehicle due to the path overlap resulting from the offset intersection. This offset is shown in **Photo 9**.
- One pedestrian collision occurred when a left-turning vehicle on East Powell Avenue struck a northbound pedestrian in the crosswalk at night. The pedestrian was crossing during the “Do Not Walk” phase.
