Executive Committee Meeting Agenda  
Thursday, November 10, 2022, 1:15 pm

# LUC Regional Planning Commission

Re: Inspection for Repair  
Bridge: CHP-DUGAN-00001  
SFN: 1160044  
Gwynne Street over Dugan Run & IORY RR

Burgess & Niple (B&N) performed an inspection for preliminary repair recommendations and costs of the above referenced bridge on July 6, 2022. The bridge is a four-span structure (**photos 1 and 2**) with spans numbered west to east and consisting of:

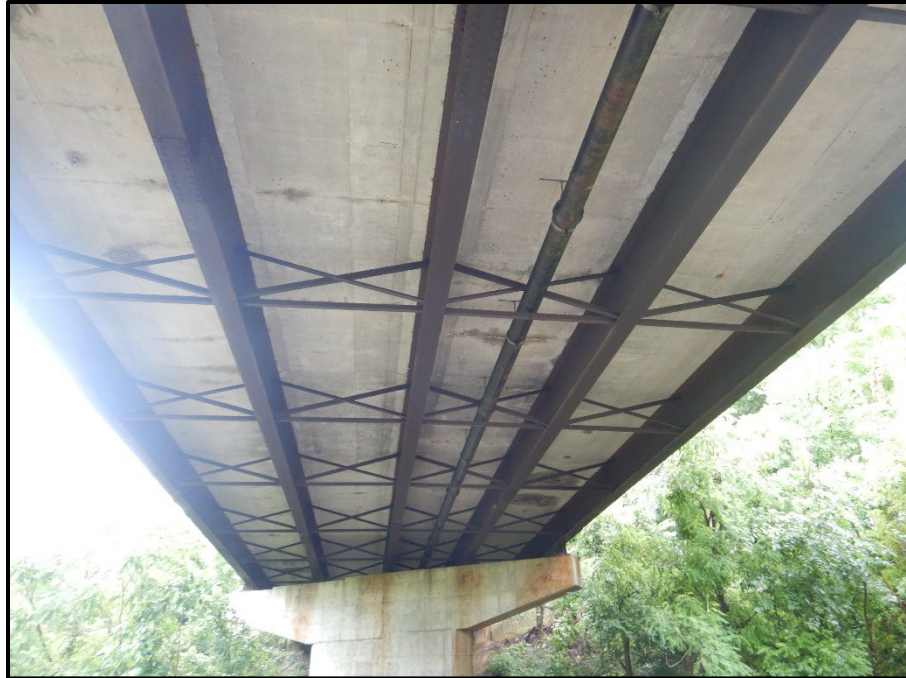
- Approximately 325 square feet of the 10,760 square foot deck underside exhibits spalling. Approximately 50 square feet of spalling exhibit exposed and corroded steel reinforcing bars with no measurable loss **(photo 3)**.
- Most of the spalls on the underside of the deck exist around the asphalt drainage pipes and heaviest near the piers **(photo 4)**. This indicates that water is seeping through the asphalt overlay and collecting on the top of the concrete deck prior to flowing through the asphalt drains. The water then saturates the bottom of the concrete deck around the asphalt drains, causing the steel corrosion and concrete spalls.

**Photo 3** – Looking east at the typical underside of span 3.

Bottom of Deck – Repair the bottom of deck concrete at locations where spalled concrete and delamination is present around the asphalt drains and at other miscellaneous locations as recommended by ODOT BDM 403.2.2. ODOT recommends for repair of an under-deck spall with exposed uncoated reinforcement, to remove all loose concrete, mechanically clean the reinforcing steel and coat with paints containing zinc dust. Provide galvanizing material conforming to ASTM A780 except aerosol spray applications will not be permitted.

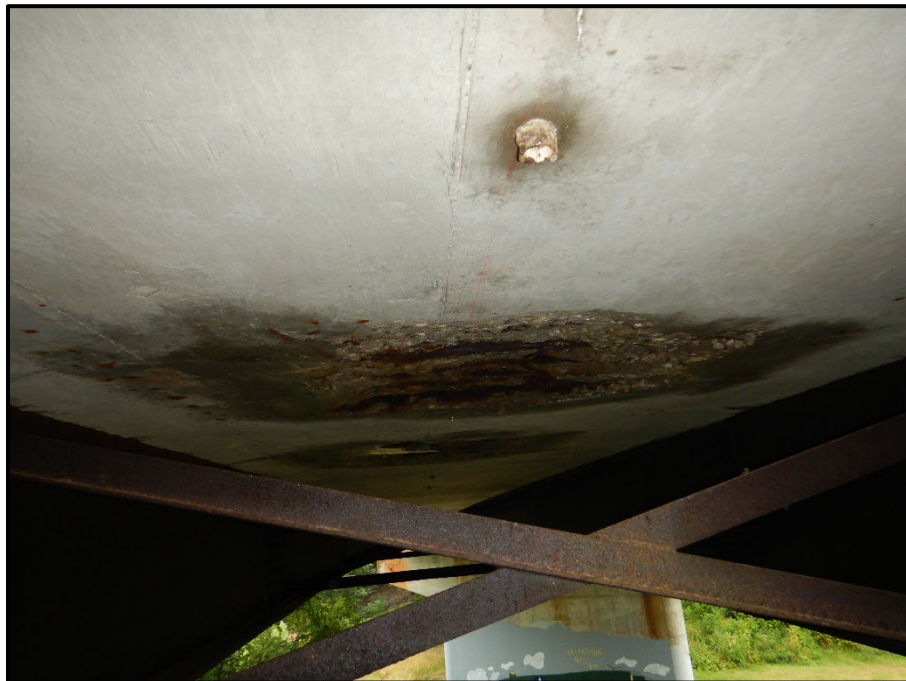
- The bridge deck drains into scuppers located on the edge of the wearing surface along both sidewalks **(photo 10)**.
- Asphalt drains are located along each curb line. The PVC drain pipes project through the concrete deck, from below the asphalt overlay to slightly below the bottom of the deck **(photo 4)**.

**Photo 4** – Looking west at the underside of the deck in span 3 bay 4 near the Center Pier. Note: two 5-foot x 5-foot spalls with exposed reinforcing steel in the underside of the deck.

Asphalt Drains - 1 inch diameter PVC deck drain pipes are located at the curb line on both sides of the bridge. The original construction plans do not show these pipes. Pipes were probably added when the first asphalt overlay was constructed (date unknown). Pipes are spaced at approximately 6 feet on centers at the edge of both sidewalks and project through the concrete deck. The purpose is to allow any drainage that seeps through the porous asphalt overlay to drain through the deck. At many locations the bottom of the concrete deck is spalled and delaminated around the pipes. Two of the pipes are located over intermediate cross-frames where outflow has caused corrosion and section loss to the cross-frame angles and adjacent beams. At one location the pipe is directly over the concrete cap at the south end of Pier 1 and outflow has caused delaminated concrete on the top and side of the concrete cap. At the three locations where outflow is pouring/spraying onto the superstructure or substructure elements, the drain pipes should be extended to outlet the drainage below the bottom of the cross-frames or pier cap. A 2-inch diameter PVC flange fitting should be attached to the bottom of the concrete deck with concrete anchors (Tapcon or equal). A 2-inch diameter section of Schedule 40 pipe with fittings to offset the cross-frames or cap and of sufficient length (approximately 4 foot long at the cross-frames and 9 foot long at Pier 1) should be glued to the flange fitting. A flexible strap attaching the pipe to the pier cap should be provided to accommodate superstructure movement and brace the pipe.

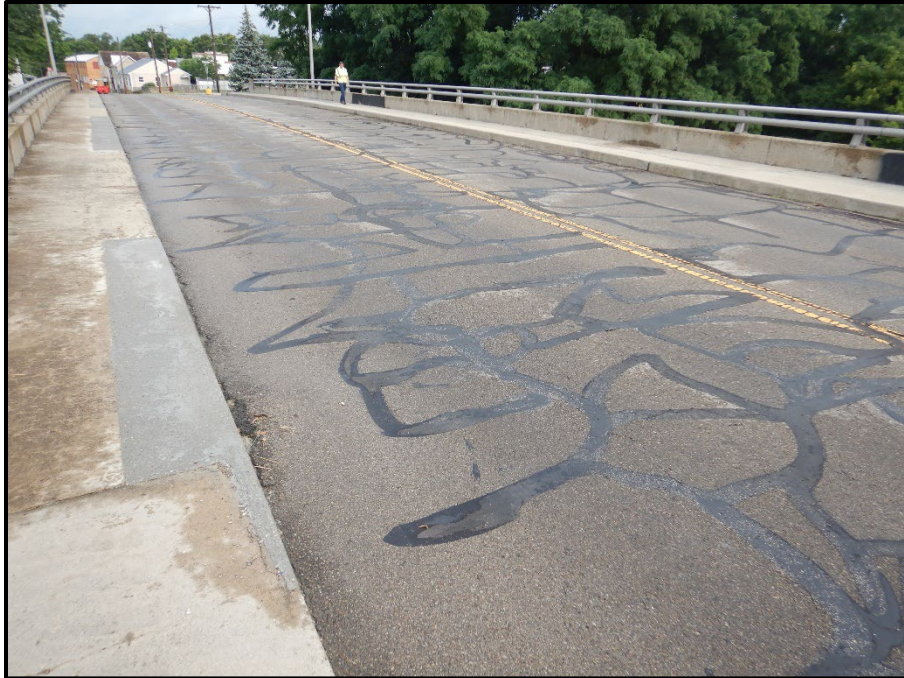
- The asphalt wearing surface is approximately 1 to 2 inch thick and appears to have been replaced multiple times **(photo 5)**.
- The asphalt on the outer 3 feet of the deck near the curb lines is unsound. This is most likely due to water being trapped between the sidewalk cold joint and the top of the concrete deck and moving under the adjacent asphalt **(photo 6)**.
- The wearing surface has sealed longitudinal and transverse cracking throughout all spans spaced approximately 3 feet apart.

**Photo 5** – Looking northwest at the typical wearing surface in span 3.

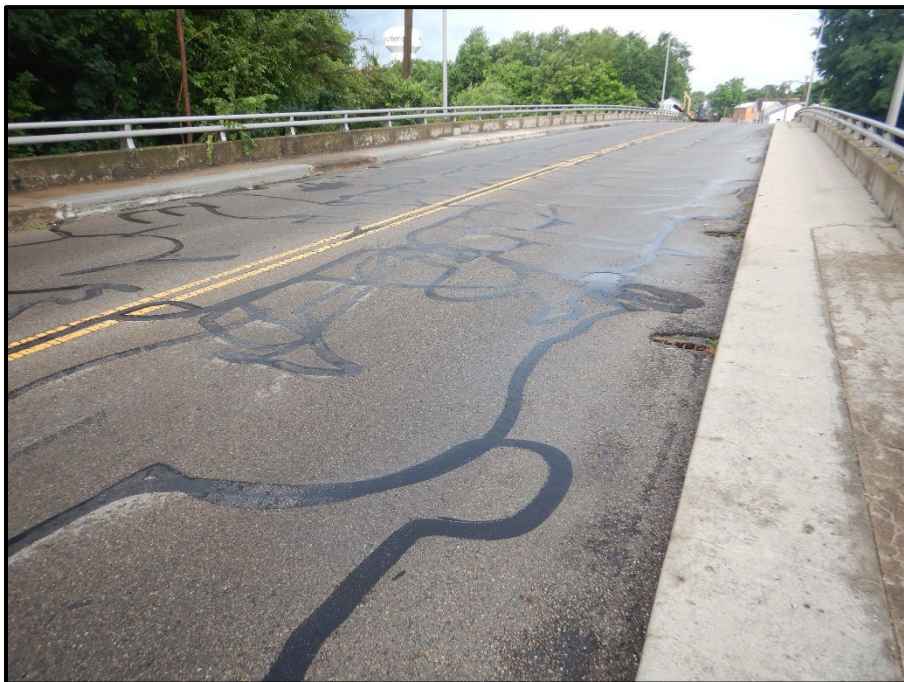
**Photo 6** – Looking southwest at the typical wearing surface condition in span 1. Note: sealed map cracking throughout. Multiple locations of concrete sidewalk repair throughout all spans.

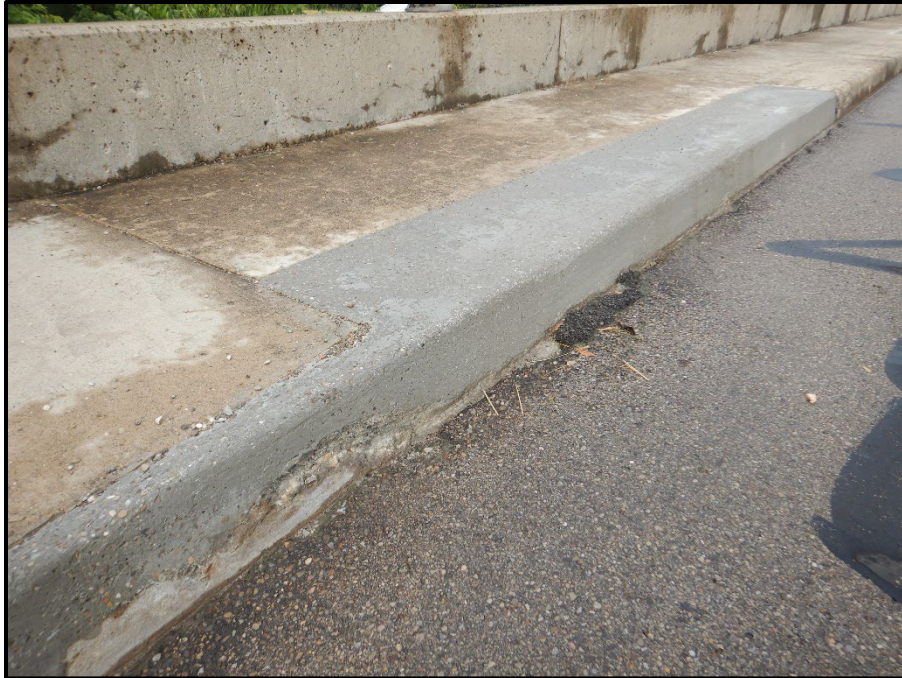
- The sidewalk and curbs were repaired in 2019 and exhibit multiple locations of minor cracking **(photo 7)**.
- Multiple sections of the sidewalk have been repaired with fiber reinforced concrete **(photo 8)**.
- Span 3 south sidewalk has a 7-foot-long x full width section of the concrete sidewalk that is scaling **(photo 8)**.
- Sidewalk exhibits hairline longitudinal cracking in unrepaired sections of concrete.

**Photo 7** – Looking south at the sidewalk repair in span 3.

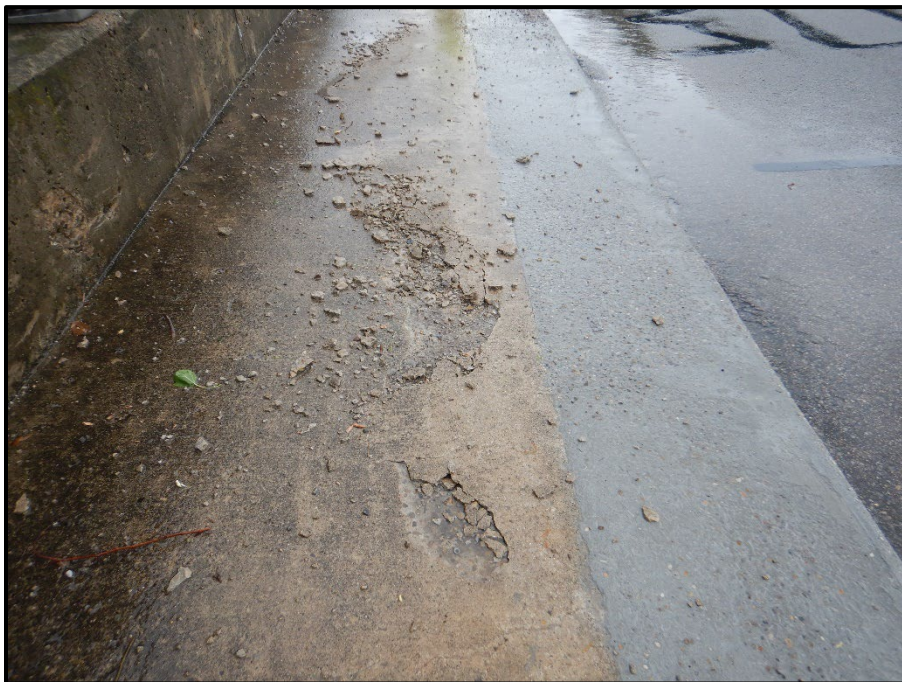
**Photo 8** – Looking west at the south sidewalk in span 3. Note: 7-foot-long section of the sidewalk is scaling.

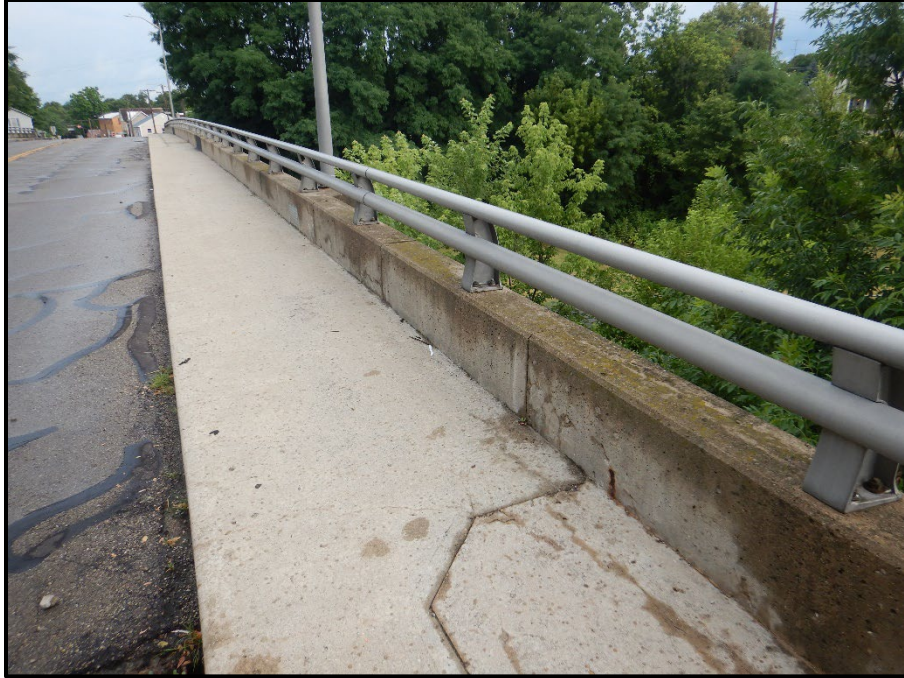
- The bridge railing consists of twin round aluminum rails anchored to a concrete parapet **(photo 9)**.
- No significant deficiencies exist to the bridge railing.

**Photo 9** – Looking northwest at the typical bridge railing in span 4.

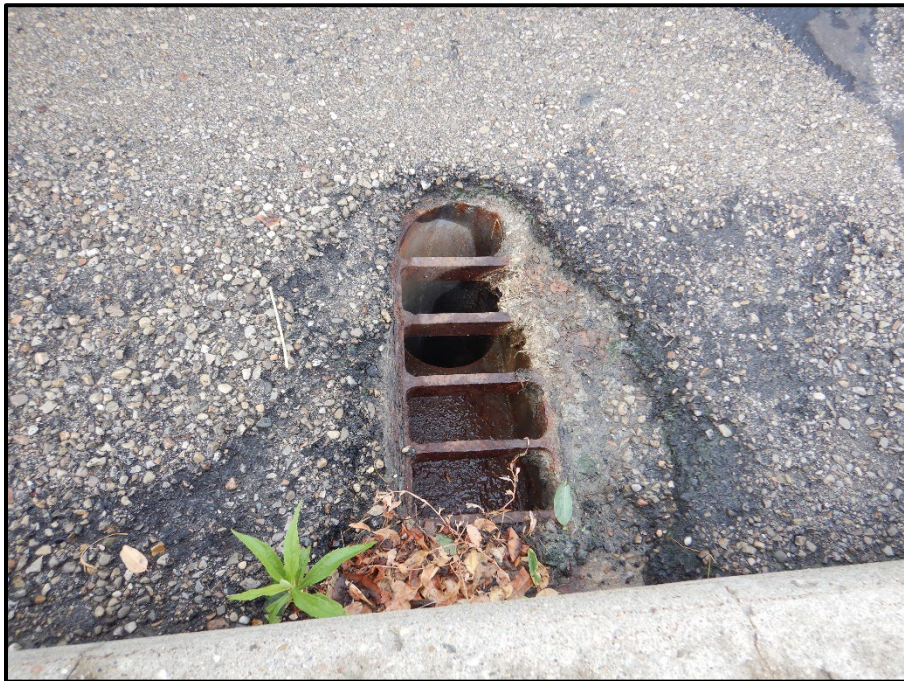
**Photo 10** – Looking south at typical deck scupper detail. Note: multiple asphalt overlays.

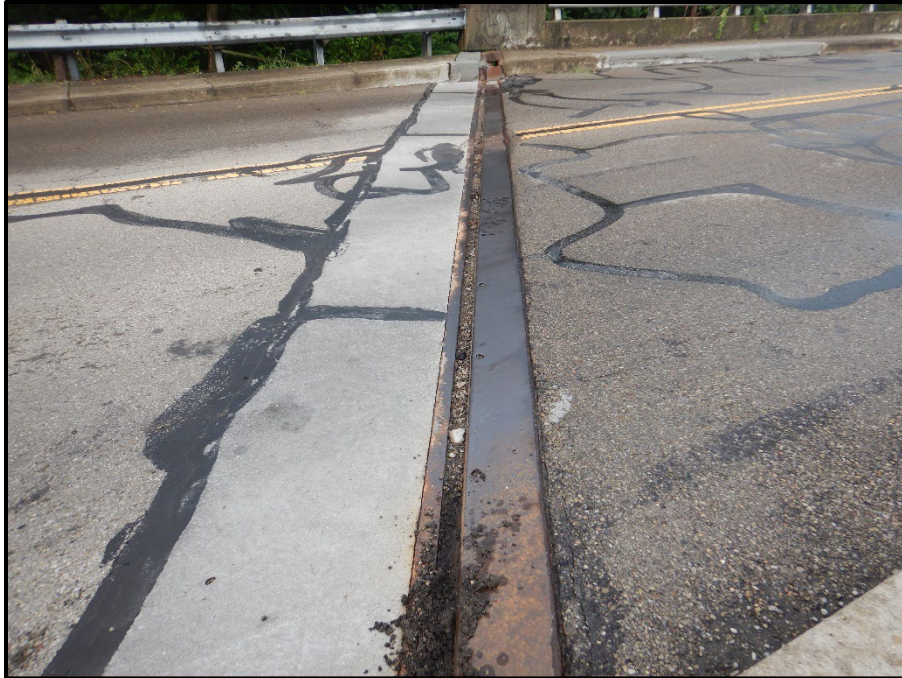
- Sliding plate expansion joints devices exist over both abutments **(photo 11)**.
- Compacted soil and debris exist in both expansion joints **(photo 12)**.
- The joints over both abutments leak allowing water to drip onto the abutment bearings, beam ends, and end cross-frames causing corrosion and section loss to these steel members **(photo 13)**.

**Photo 11** – Looking south at the sliding plate joint over the Rear Abutment. Note: soil and debris are accumulating in the joint.

End Dam (sliding plate expansion joint) – The sliding plate expansion joint devices are leaking and allowing drainage to saturate the concrete substructures and weathering steel superstructure members. A repair that provides a watertight expansion joint device should be

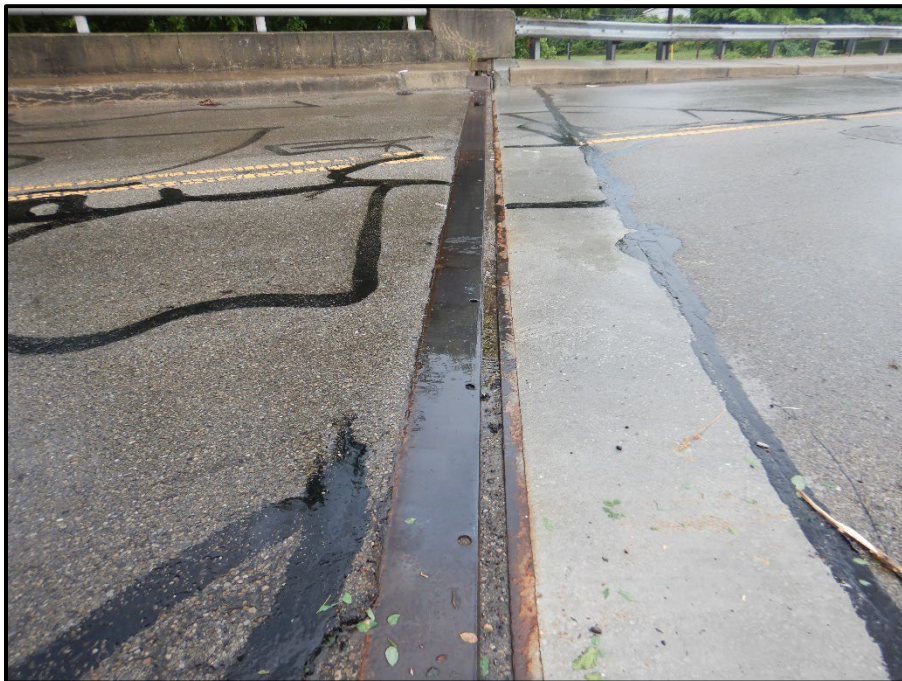
**Photo 12** – Looking south at the sliding plate joint over the Forward Abutment. Note: soil and debris are accumulating in the joint.

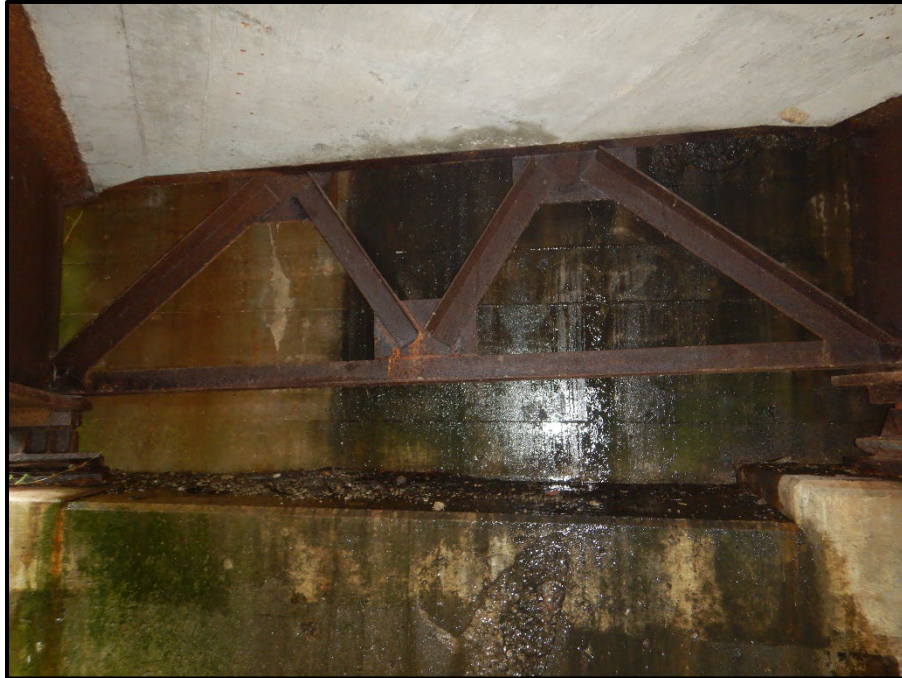
**Photo 13** – Looking east at the end cross-frame between beams A and B at the Forward Abutment. Note: heavy surface corrosion exists on the end cross-frames due to water infiltration through the deck joint.

End cross-frames – Deck drainage leaking through the sliding plate expansion joints at the abutments has caused corrosion and section loss to the end cross-frames. Several of the welds attaching the cross-frame angles to the connection plates are broken. At locations where the existing angles are in good condition with broken connection welds, the existing welds should be removed by grinding and the existing angles should be re-welded. Existing angles with holes and section loss should be removed and replaced with new angles.

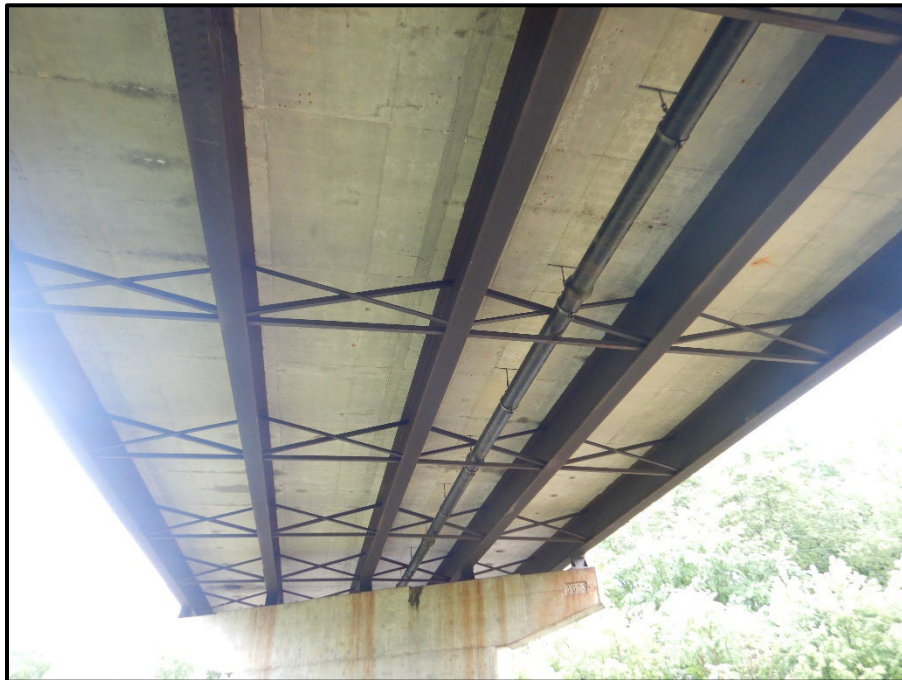
- The floor system consists of five W36x94 wide flange beams spaced 9' 0" on center with welded cross-frame bracing between beams **(photo 14)**.
- The end 4-feet of the beams at the Rear and Forward Abutments exhibit corrosion and minor section loss at the following locations. The section loss is heaviest in the webs and bottom flange.

**Photo 14** – Looking east at the underside of span 2.

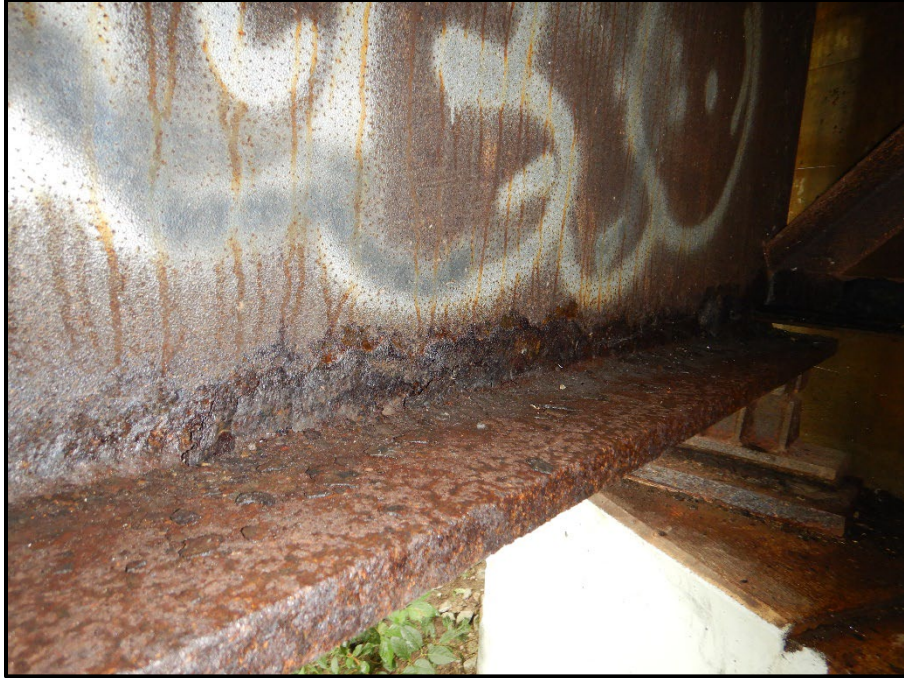
- Beam A at the Rear Abutment.
  - Beam D at both abutments.
  - Beam E at the Rear Abutment **(photo 15)**.
- Span 4, beam D at the Forward Abutment has laminar corrosion with up to 1/8-inch-deep section loss in the bottom flange to the end 15 feet of the beam.

**Photo 15** – Looking southwest at span 1 beam E at the Rear Abutment. Note: laminar corrosion typical on the end 4 feet the steel beams at both abutments.

Clean and paint portions of superstructure – The beam ends, end cross-frames and bearings at the abutments should be cleaned and painted with a three coat system as recommended by ODOT BDM 702.9, Partial Painting of A709 Grade 50W Steel, which recommends painting 10 feet of each beam end adjacent to the abutments including all cross-frames and other steel within these limits. The steel should be abrasively cleaned according to ODOT Construction and Material Specification (C&MS) 518 and a prime coat applied according to C&MS 708.01. An intermediate coat shall be applied and the topcoat color shall closely approach Federal Standard No. 595B - 20045 or 20059 (the color of weathering steel). The corroded areas of Beam 1, Span 1 and Beam 4, Span 4 at the deterioration due to drainage running down the intermediate cross-frame diagonal angles from the asphalt drains should also be cleaned and painted.

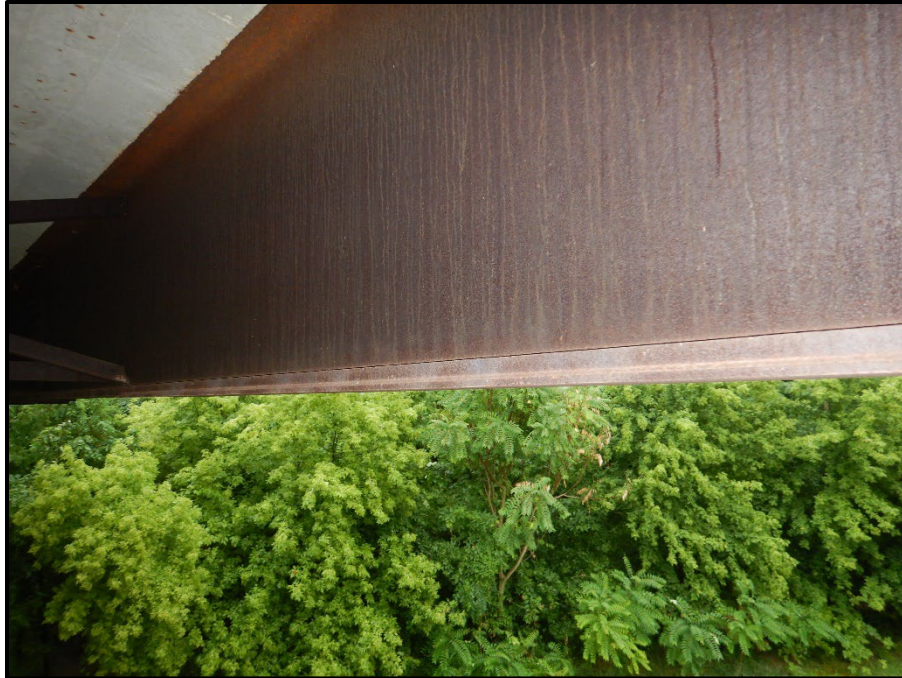
**Photo 17** – Looking southeast at beam E in span 3. Note: moment plates are wider than the bottom flange.

Moment plates - The steel beams have welded top and bottom moment plates at the piers. Section 404.1.2.4.a of the ODOT BDM provides guidance on rehabilitating structures with moment plates. If cracked welds are not visible, the bridge is not located on a principle arterial road and the average daily truck traffic is less than 500 vehicles per day, a fatigue analysis and retrofitting the ends of the moment plates are not required. The structure appears to meet these requirements, so alterations to the moment plates are not anticipated to be necessary. However, if a future deck replacement is performed, the welds at the ends of the top flange moments plates should be carefully inspected. The inspection will need to occur after the deck is removed. If cracks are found, moments plates should be retrofitted according to ODOT details. Costs for retrofitting moment plates have not been included in the estimated repair costs below.

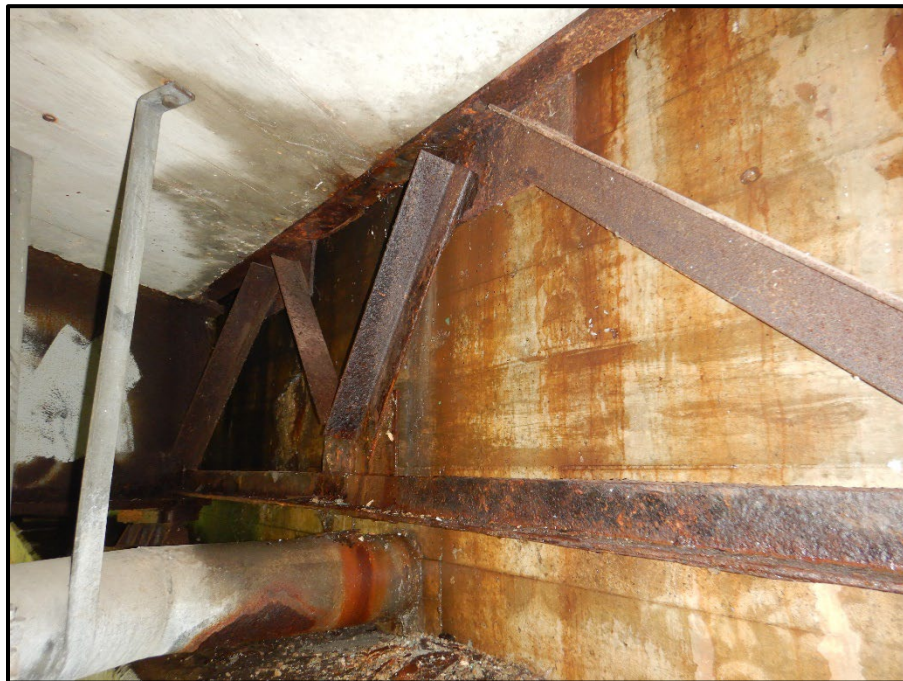
- Intermediate cross-frames are comprised of end welded steel angles with two diagonals and one bottom horizontal **(photo 18)**. End cross-frames are comprised of multiple end welded steel angles with gusset plates and top and bottom horizontal angles.
- The intermediate cross-frames are perpendicular to the beams and not normal to the skew.
- The Span 4 end cross-frame between beam D and E is missing one diagonal angle **(photo 19)**. The angle appears to have fallen away due to pack rust breaking the welds.
- Multiple end cross-frames have broken welds **(photos 20 and 21)**.
- Multiple intermediate cross-frames are under asphalt drains and exhibit laminar corrosion with section loss **(photos 22 and 23)**.

**Photo 18** – Looking southeast at the end cross-frame between beams D and B at the Rear Abutment. Note: up to 1/4-inch section loss to the bottom strut angle.

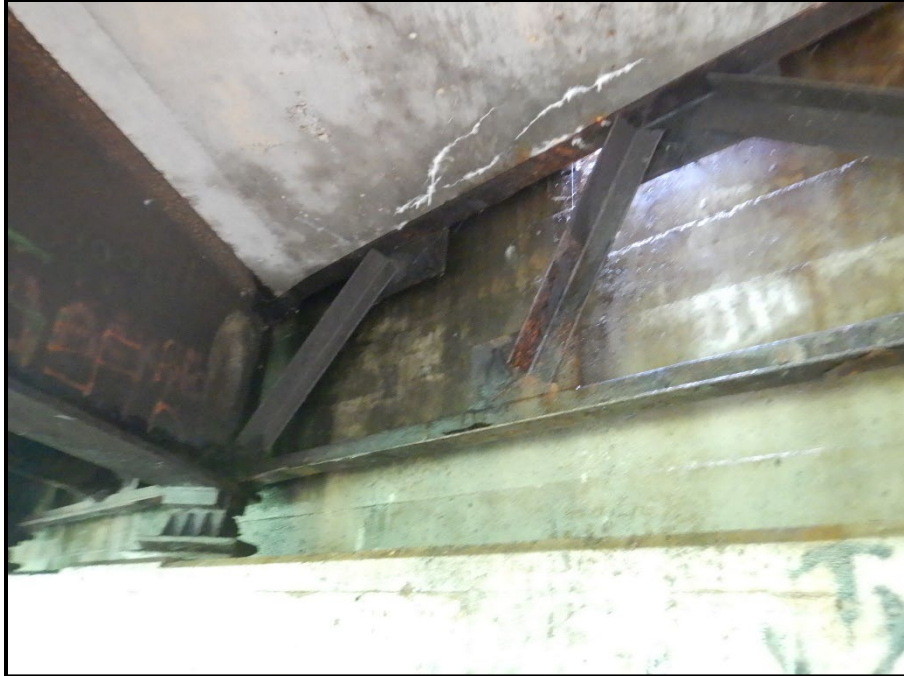
**Photo 19** – Looking east at the end cross-frame between beams D and E at the Forward Abutment. Note: missing diagonal angle.

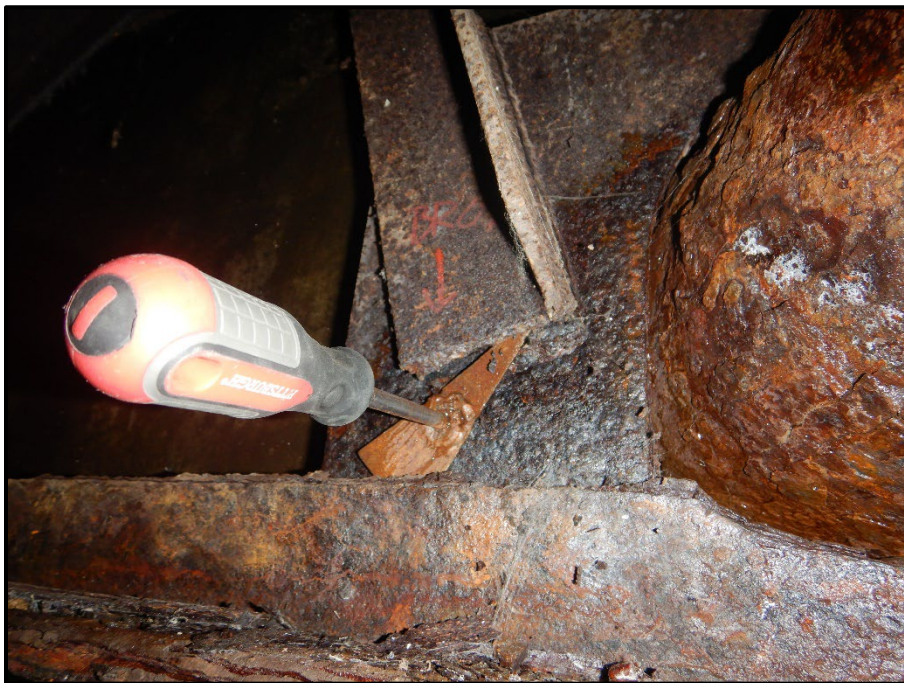
**Photo 20** – Looking east at the end cross-frame between beams C and D at the Forward Abutment. Note: broken diagonal angle weld.

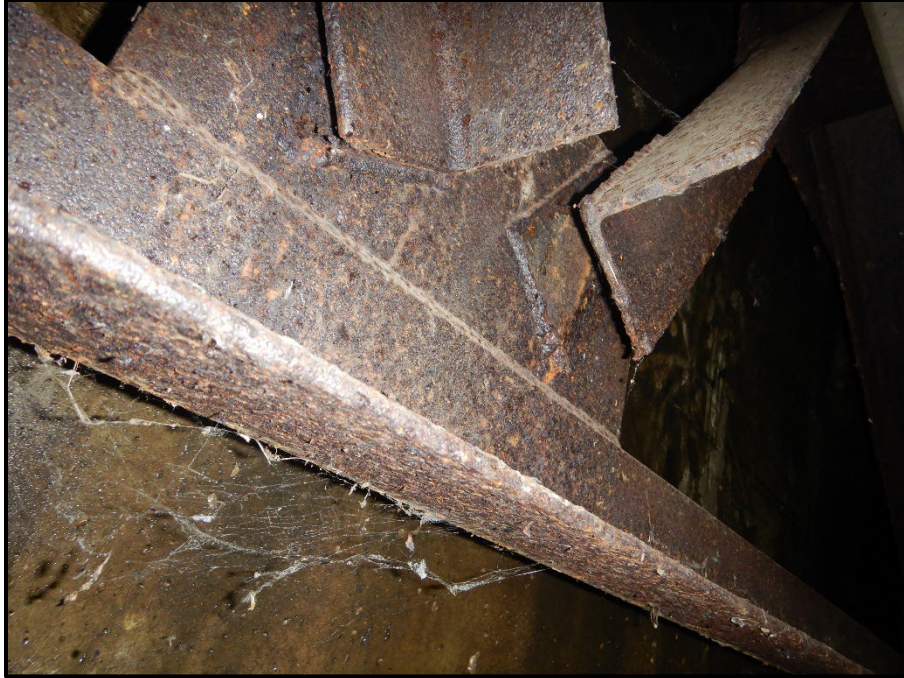
**Photo 21** – Looking east at the end cross-frame between beams B and C at the Forward Abutment. Note: broken diagonal angle weld.

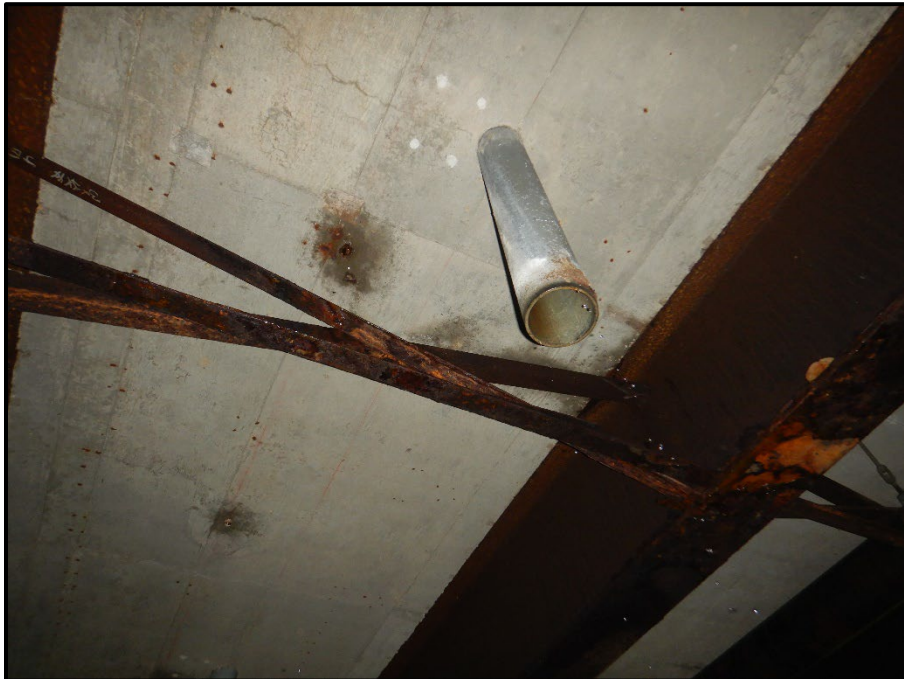
- Span 4, beam D at cross-frame 17 exhibits surface corrosion and laminating corrosion due to flow from asphalt drains running onto the cross-frame and down onto the beam. This condition exists at multiple locations. Extending the drainpipes below the bottom of the beams will prevent water from draining onto the beams and cross-frames.

**Photo 22** – Looking west at the scupper drain and asphalt drain in span 4 between beams D and E at cross-frame 17. Note: asphalt drain is directly over intermediate cross-frame and drainage flows onto diagonal member and down to the bottom flange of the beam.

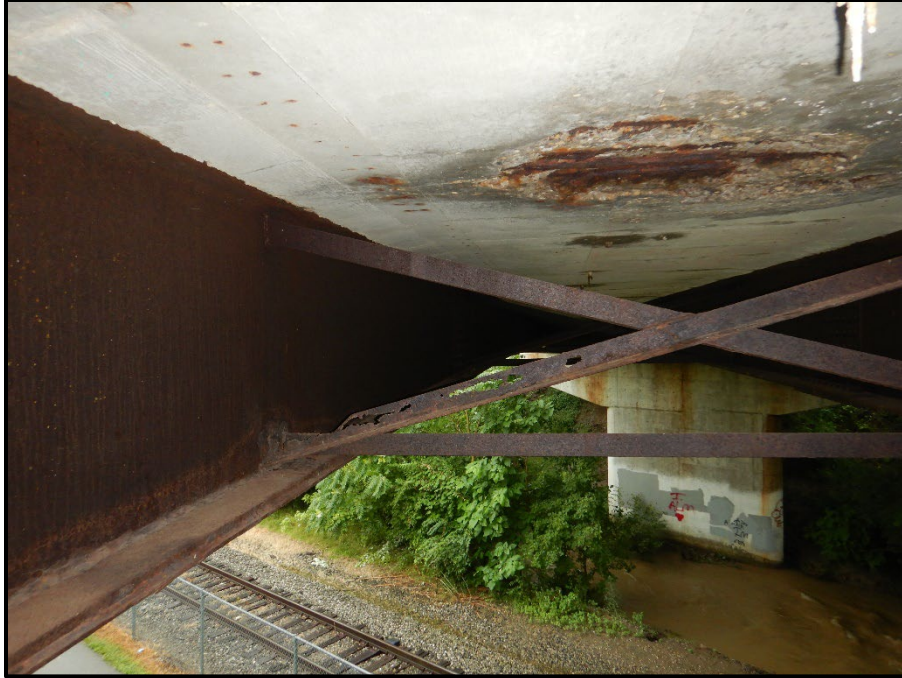
**Photo 23** – Looking at span 3 intermediate cross-frame 10 between beams B and C near the Center Pier. Note: bottom of concrete deck spall and full depth corrosion holes exist in the cross-frame diagonal due to flow from the asphalt drain.

Intermediate cross-frames – At Beam 1, Span 1, Cross-Frame 1.3 and Beam 4, Span 4, Cross-frame 4.3 the intermediate cross-frame angles have corrosion and section loss due to drainage from the asphalt drains. The existing cross-frame angles should be removed and replaced with new angles.

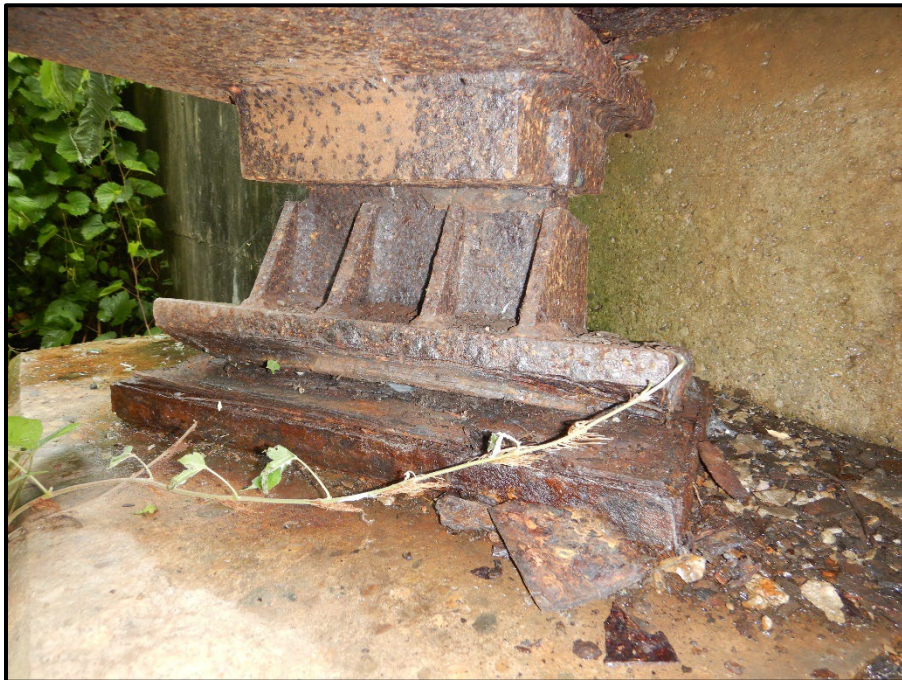
- Rocker bearings at both abutments exhibit corrosion and minor section loss (**photos 24 and 25**).
- The bearings are still functioning as intended.
- To prevent further corrosion the bearings at the abutments the bearings should be abrasively cleaned and painted. The expansion joints over the abutments should be replaced with sealed joints to help prevent deck drainage from draining onto the bearings.

**Photo 24** – Looking north at the rocker bearing under beam A at the Forward Abutment. Note: laminar corrosion exists to the masonry plate due to a leaking expansion joint.

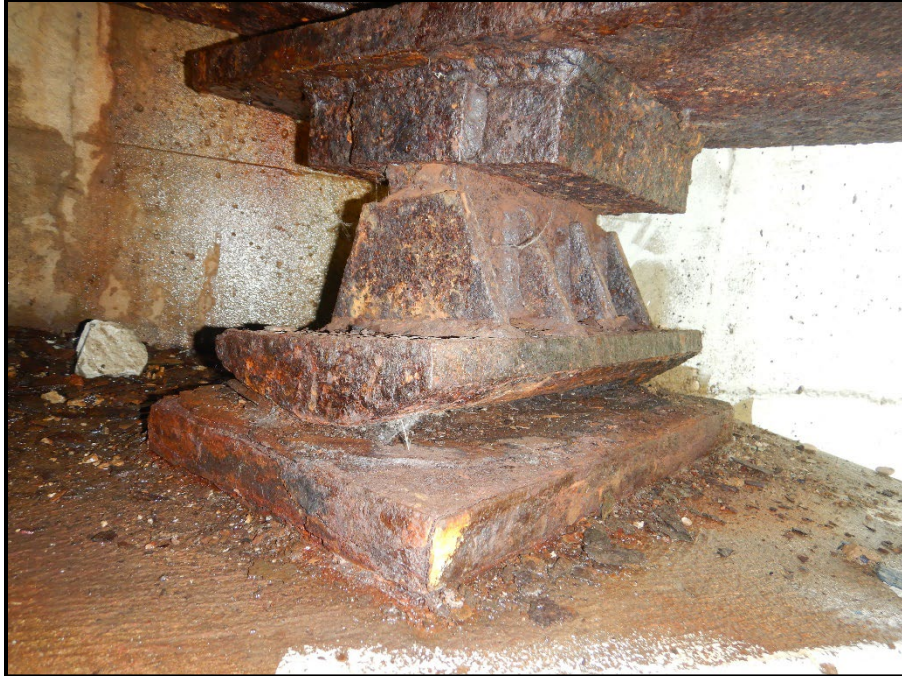
**Photo 25** – Looking northwest at the beam A rocker bearing at the Rear Abutment. Note: laminar corrosion with up to 1/8 inch loss to the masonry plate and bearing interface.

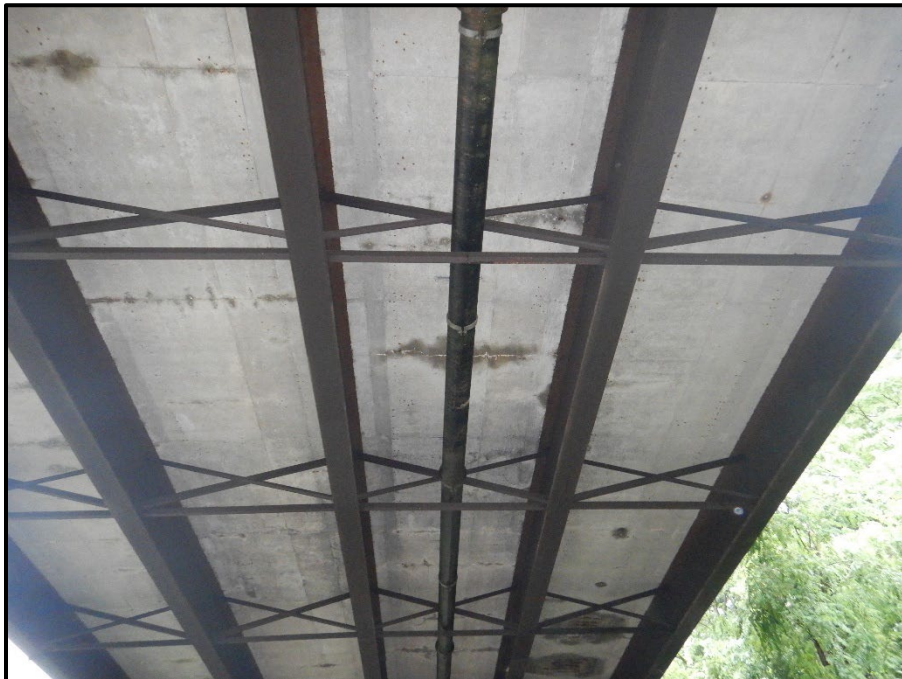
- A water pipe exists between beams C and D for the full length of the structure and penetrates both abutments back walls (**photo 26**). Sweating of the pipe during the summer months will cause deterioration of the adjacent cross-frames.

**Photo 26** – Looking east at the water pipe running between beams C and D.

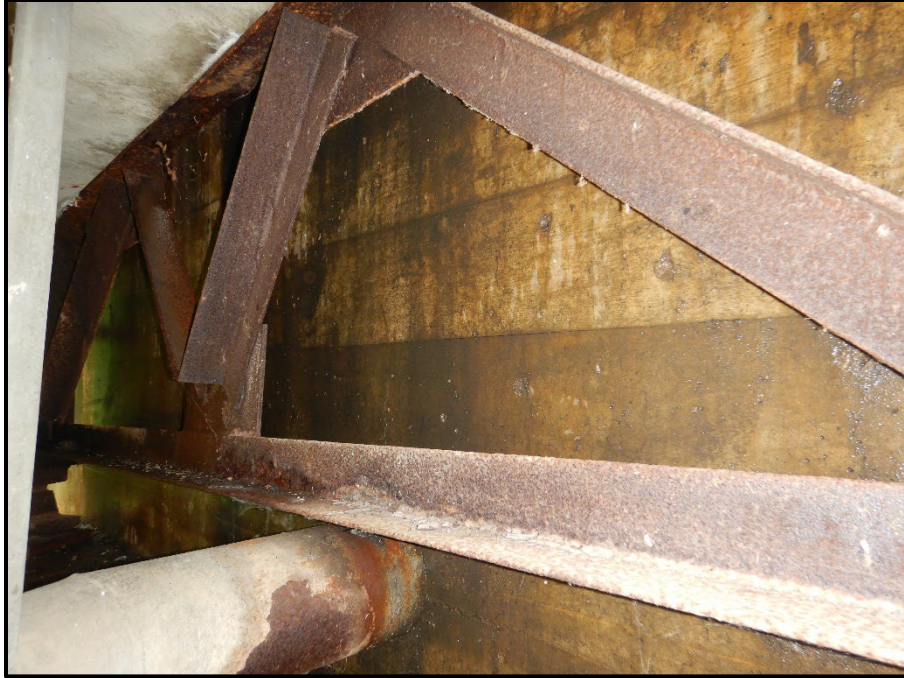
- Multiple full height vertical cracks up to 0.009-inch-wide exist in both abutment backwalls (**photo 27**).
- The Rear (west) Abutment footer is exposed 3-feet-vertically for 10-linear-feet under beams 1 and 2 (**photo 28**).
- Deck drainage passes through the expansion joint and onto the abutment backwalls at both abutments (**photo 29**).

**Photo 27** – Looking southwest at the water staining and cracking in the Rear Abutment backwall.

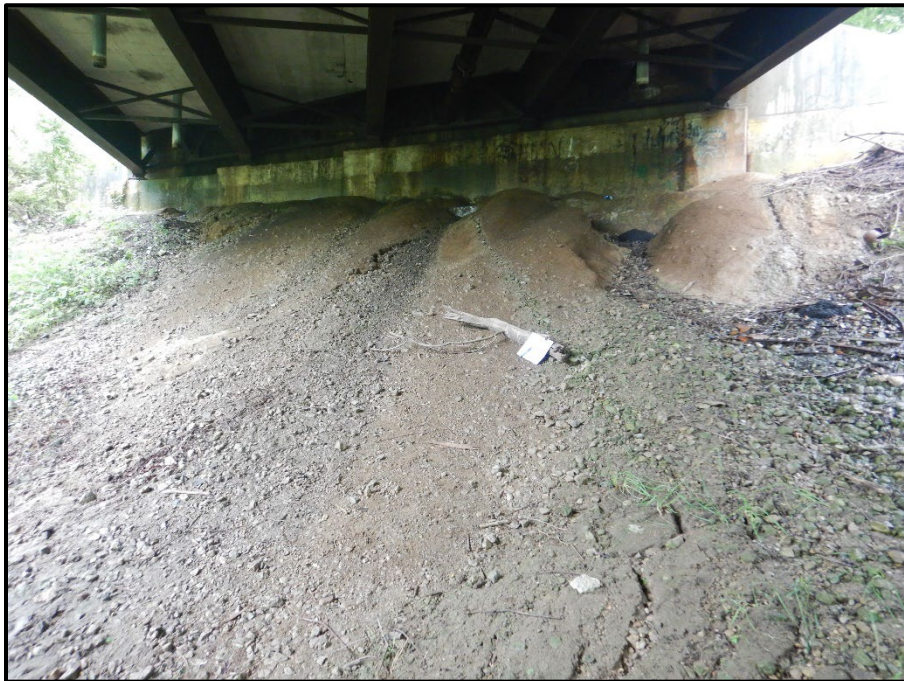
- Most of the slope protection is missing at the embankments at both abutments **(photo 28)**.
- Deep erosion ditches exist at both abutment embankments **(photo 34)**.

**Photo 28** – Looking east at multiple erosion ditches formed by scupper drainage in embankment in front of the Forward Abutment. Similar conditions are present at the Rear Abutment embankment.

Slope protection – The original crushed aggregate slope protection is in poor condition. Erosion is present below the deck drain down spouts. Larger aggregate should be used to minimize erosion due to the quantity of the deck drain flows. Ditches constructed of ODOT Type B Rock Channel Protection with Filter Fabric should be constructed (5'-0" wide by 1'-6" thick) at four locations below the deck drains from the face of the abutments to near the bottom of the 2 (horizontal) : 1 (vertical) slopes, ending at the Ordinary High Water Mark (OHWM).

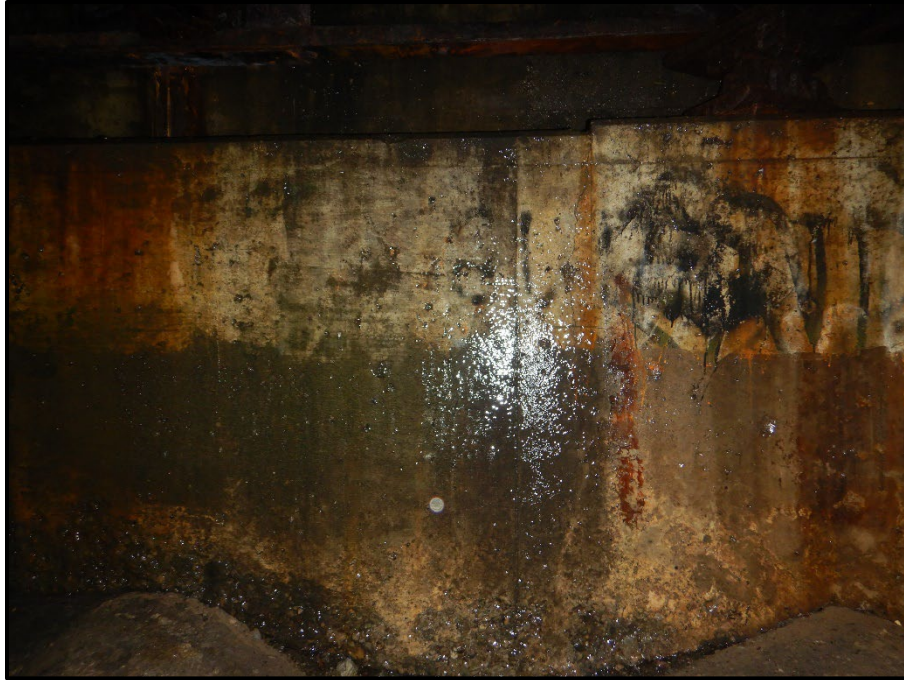
**Photo 29** – Looking east at active water leakage down the Forward Abutment backwall.

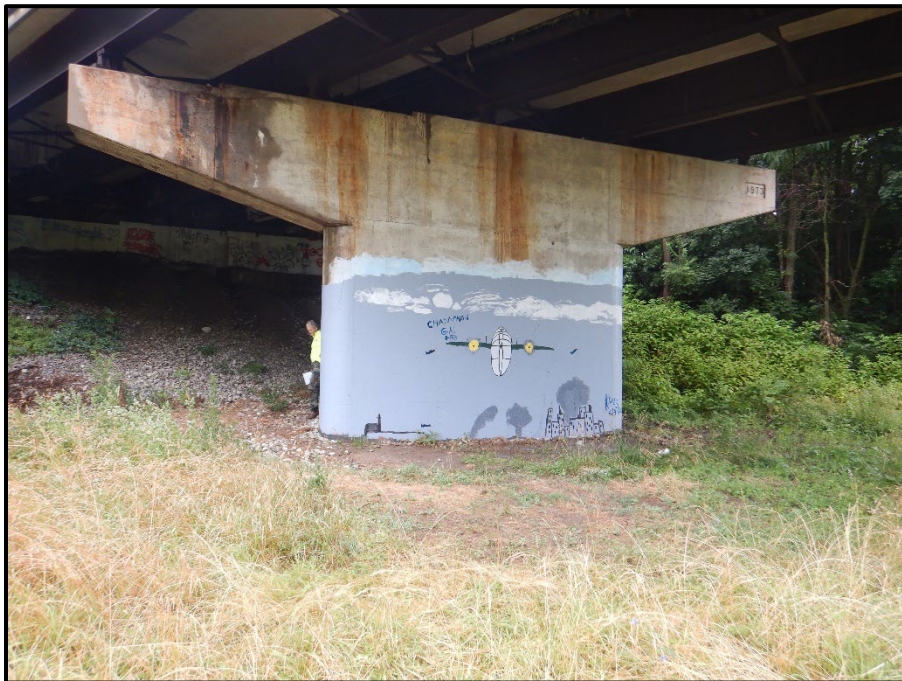
- The hammer head reinforced concrete pier caps are in satisfactory condition (**photo 30**).
- The south end, east face of the Center Pier cap exhibits multiple shear cracks emanating from below the beam E bearing (**photo 31**).
- The southeast end, top edge of the Rear Pier cap between beams D and E exhibits a 2-foot-wide x 4-foot-long x 6-inch-tall delamination (**photo 32**). A deck drain is directly over the pier cap exposing this area to moisture during rain events.
- Water staining exist on all faces of the piers under all five beams.

**Photo 30** – Looking west at the elevation view of the Rear Pier.

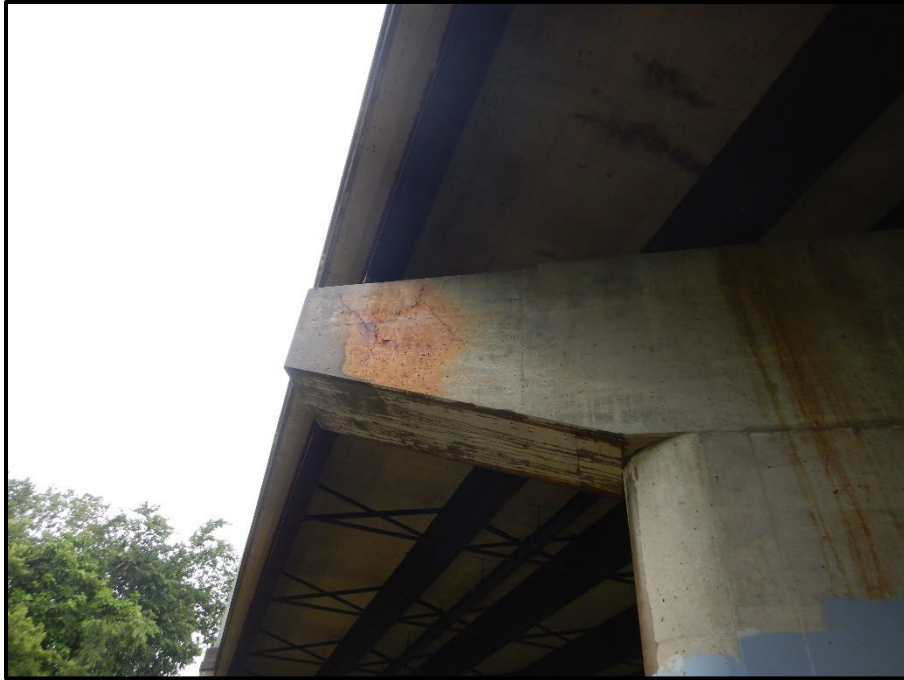
**Photo 31** – Looking west at the south end, east face of the Center Pier cap. Note: multiple shear cracks emanating from the beam E bearing.

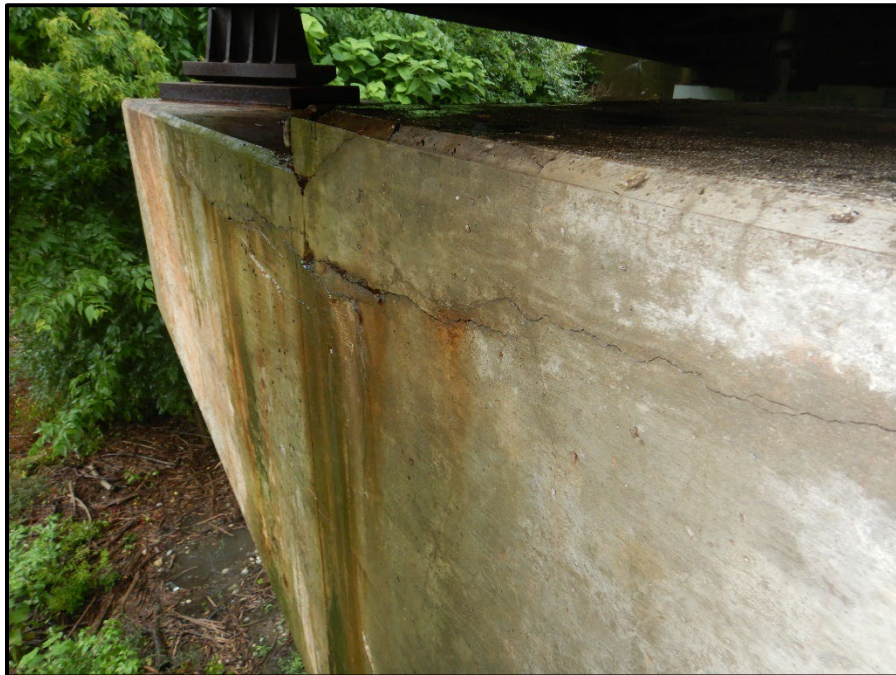
**Photo 32** – Looking south at the south end, east face top corner of the Rear Pier between beams D and E. Note: 2-foot-wide x 4-foot-long x 16-inch-tall delamination caused by asphalt drain located directly above the cap.

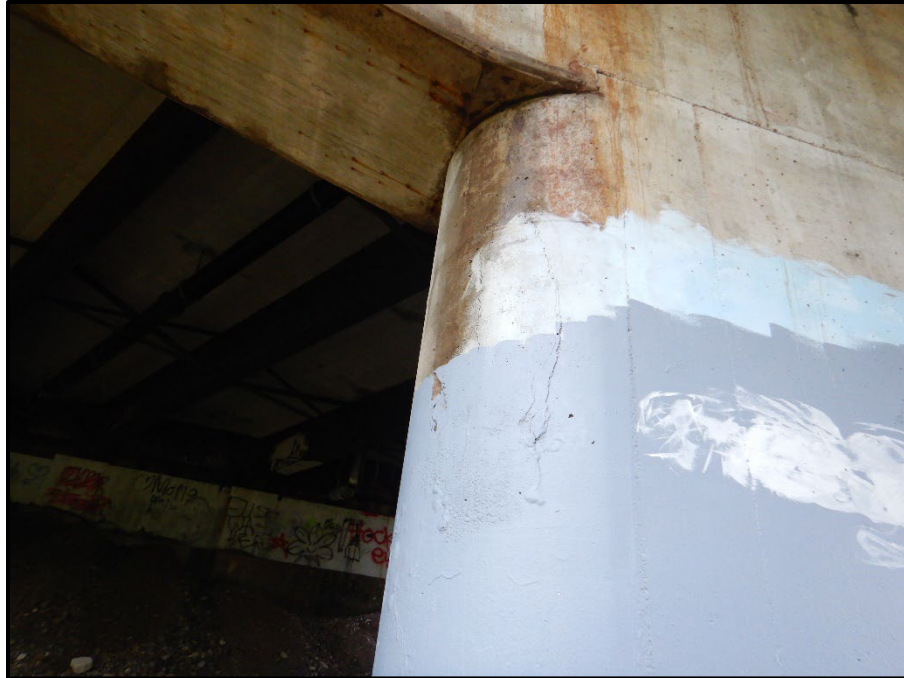
- The south end, east face top of the Rear Pier wall exhibits a 4-foot-tall x 2-foot-wide delamination caused by drainage flowing down the face of the wall through an asphalt drain directly over the cap (**photo 33**).

**Photo 33** – Looking west at the south end of the Rear Pier wall. Note: 4-foot-tall x 2-foot-wide delamination caused by an asphalt drain discharging onto the top of the pier cap.
