Executive Committee Meeting Agenda  
Thursday, November 10, 2022, 1:15 pm

# LUC Regional Planning Commission

Re: Inspection for Repair  
Bridge: CHP-DUGAN-00001  
SFN: 1160044  
Gwynne Street over Dugan Run & IORY RR

Burgess & Niple (B&N) performed an inspection for preliminary repair recommendations and costs of the above referenced bridge on July 6, 2022. The bridge is a four-span structure (**photos 1 and 2**) with spans numbered west to east and consisting of:

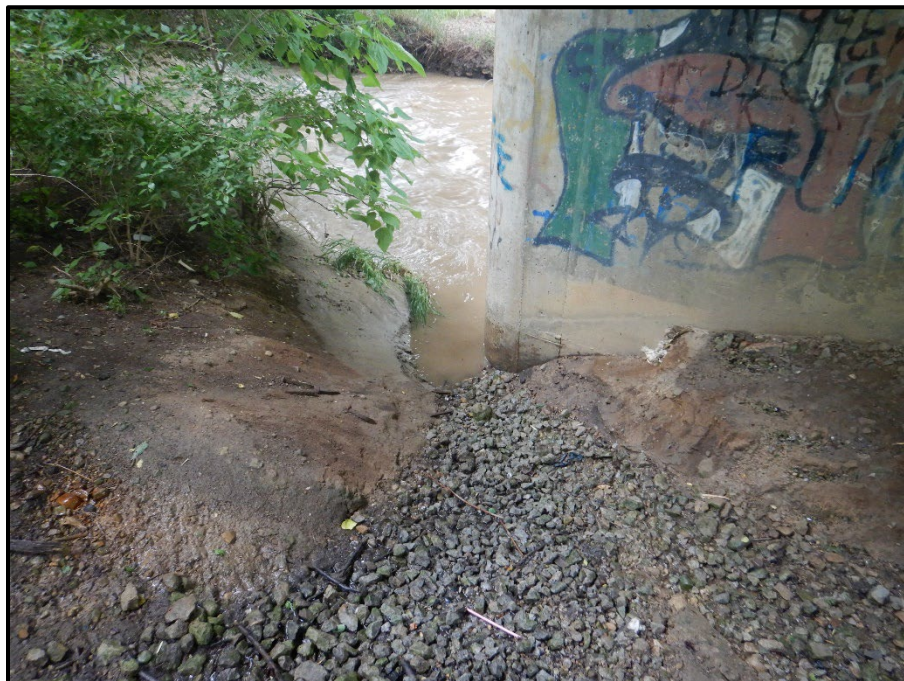
**Photo 34** – Looking west at the scour hole at the end of an erosion ditch at the south end of the Forward Pier.

Slope protection – The original crushed aggregate slope protection is in poor condition. Erosion is present below the deck drain down spouts. Larger aggregate should be used to minimize erosion due to the quantity of the deck drain flows. Ditches constructed of ODOT Type B Rock Channel Protection with Filter Fabric should be constructed (5'-0" wide by 1'-6" thick) at four locations below the deck drains from the face of the abutments to near the bottom of the 2 (horizontal) : 1 (vertical) slopes, ending at the Ordinary High Water Mark (OHWM).

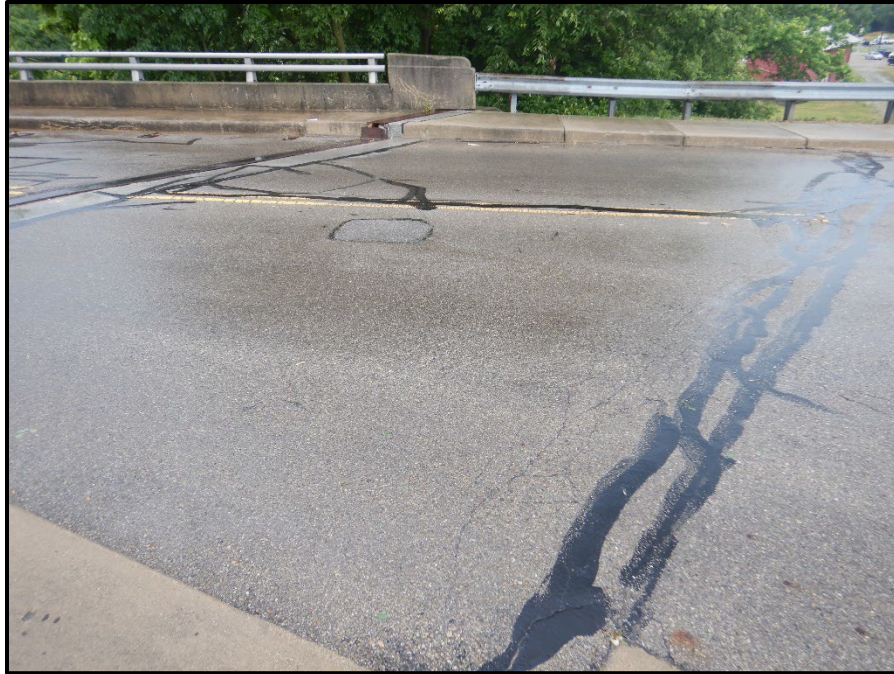
- The approach roadway has sealed map cracking at both approaches **(photo 35)**.
- The approaches to bridge deck transitions are smooth.

**Photo 35** – Looking south at the west approach roadway. Note: multiple sealed transverse and longitudinal cracks in the approach roadway.

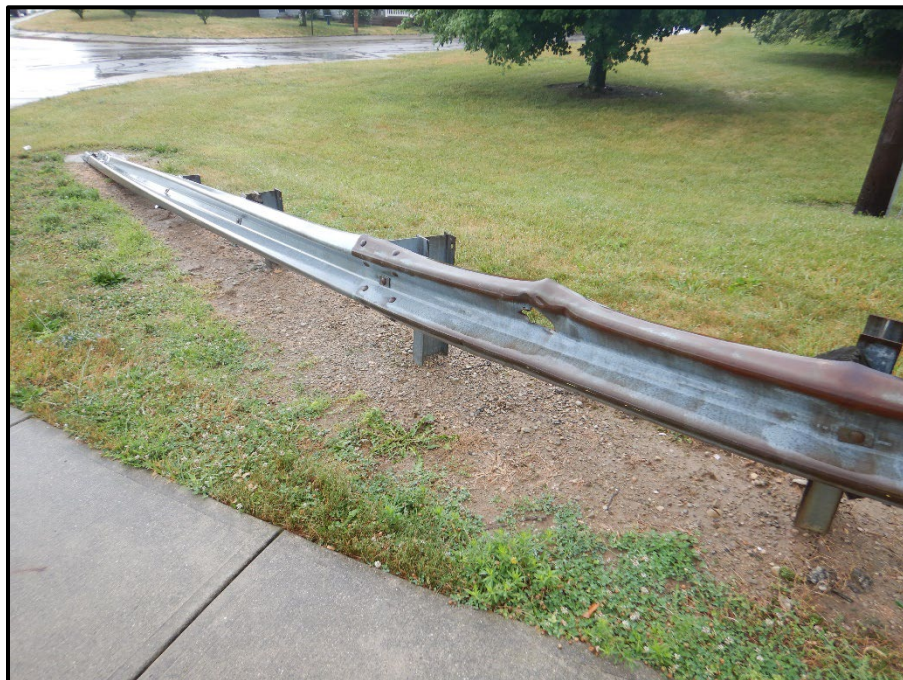
**Photo 36** – Looking northwest at the northwest approach guardrail. Note: turn down end treatment.

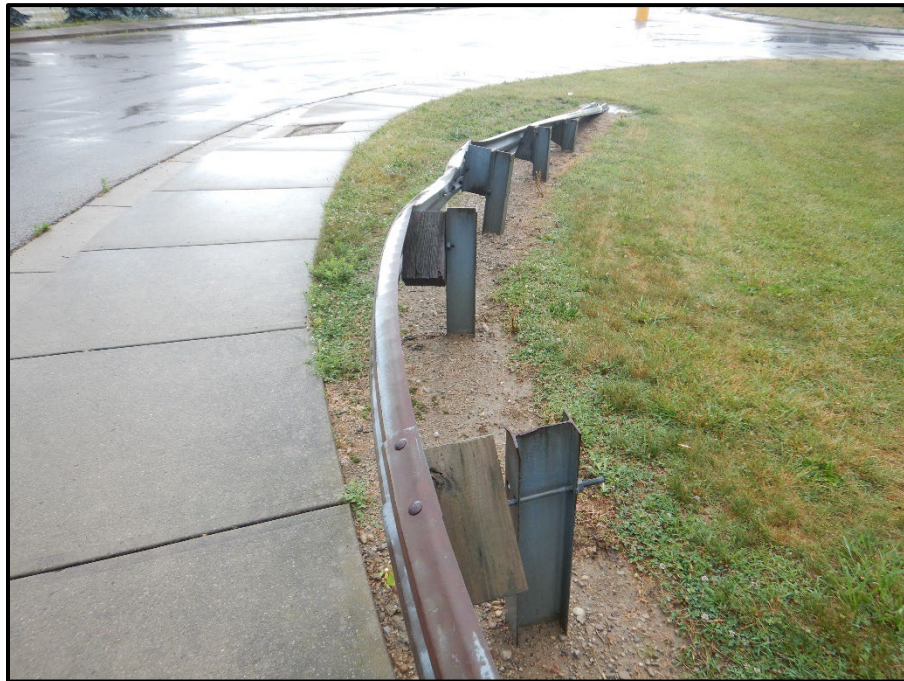
- The approach railing has turn down end treatments at all four corners **(photo 36)**.
- Minor impact damage exists to the northwest bridge railing **(photo 37)**.

**Photo 37** – Looking west at the northwest approach guardrail. Note: 5-foot-long section of impact damaged guardrail and multiple twisted and loose timber block outs.
