**To:** Louis Agresta  
*Clark County-Springfield Transportation Coordinating Committee*

**June 30, 2022**

**Subject:** Miami Street Safety Study

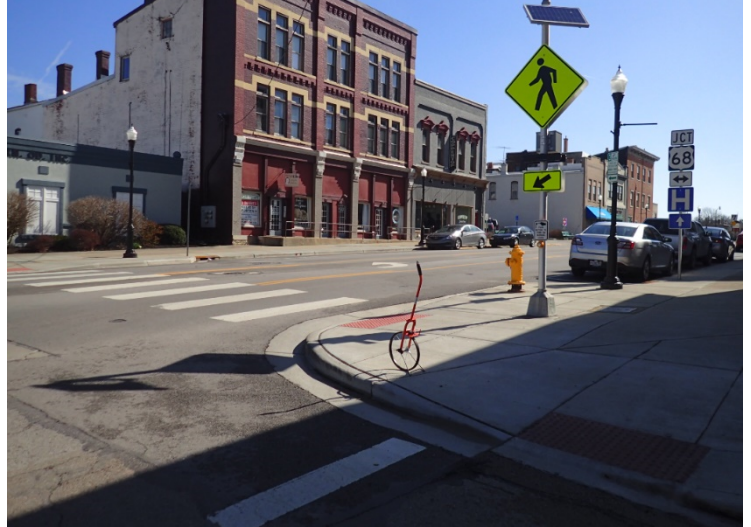
**Photo 1: Northbound Approach at Walnut Street**

- Three angle collisions occurred due to northbound vehicles on Walnut Street failing to yield to vehicles on Miami Street.
- During the site visit it was observed the northbound sight distance to the east was slightly obstructed by parked vehicles, shown in **Photo 1**.

- Add a “right-turn only” sign on the northbound approach to help mitigate angle collisions at this location.

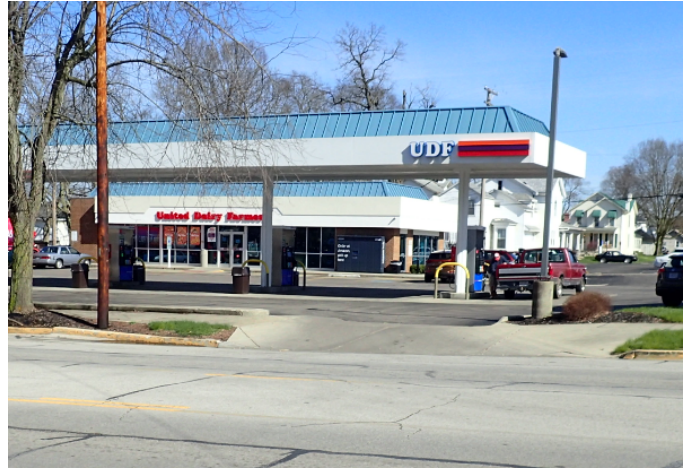
**Photo 2: Eastern UDF Driveway**

- In the five year period, no crashes occurred on this section of Miami Street.
- The eastern driveway of the United Dairy Farmers (UDF) operates as a right-in only driveway, but no signage or striping is provided to indicate the traffic control, shown in **Photo 2**.
- Transverse striping in front of the western UDF driveway separates the TWLTL and the exclusive westbound left-turn lane at High Street. This striping is located too close to the driveway, resulting in vehicles driving on the transverse striping to turn into the driveway. The striping is shown in **Photo 3**.

- Add pavement marking hatching to reinforce that the driveway is right-in only at the eastern UDF driveway.
- Add a directional pavement arrow and a “Do Not Enter” sign. This would need to be implemented by the UDF private property owner.
- Shorten the transverse striping and extend the TWLTL to facilitate left-turn movements into the western driveway at the UDF.
- Delineate on-street parking with striping along this corridor. The method for striping the parking would include solid lines parallel to the travel lane and perpendicular tick marks to indicate each parking stall. Clearly marking the on-street parking will help prevent vehicles from driving in the parking lane and will likely slow vehicle speeds by reducing the width of the roadway. Slower speeds will result in less severe crashes and a safer roadway for bicyclist and pedestrians.

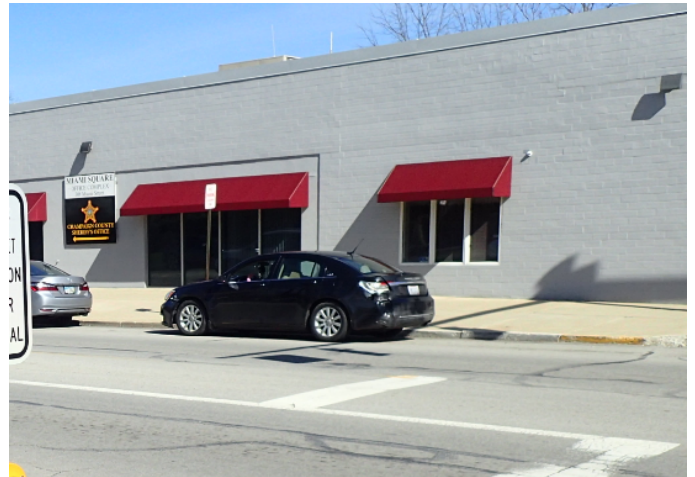
**Photo 4: Parking In Front of Caring Kitchen**

- In the five-year period, six angle collisions occurred at this intersection. Half of the angle collisions were between northbound vehicles and westbound vehicles with the westbound driver being at fault by running the red light.
- The eastbound left-turn lane on Miami Street is narrow with a width of 10 feet.
- Two parked vehicle collisions occurred at the loading zone by the Caring Kitchen, likely due to vehicles parking close to the intersection, shown in **Photo 4**.
- The current 25-mph speed limit sign is mounted at a substandard height and location, shown in **Photo 5**. Due to the vehicles parked close to the intersection, this speed limit sign is often obstructed.

- Shift the lanes toward the southern side of Miami Street by removing parking to provide more width in the eastbound left-turn lane.
- Relocate the 25-mph speed limit sign to the east side of the intersection and ensure that it is installed at an appropriate height.
- Delineate a clear loading zone on the northern side of Miami Street west of High Street.
- Modify the northbound and southbound red clearance intervals from 1 second to 1.4 seconds based on clearance interval calculations performed at the intersection. These calculations are provided in **Attachment 5**.
- Add backplates to the eastbound and westbound approaches. The backplates may require that the signal be reconstructed to support the additional wind load. A more detailed analysis should be performed to determine the structural effects of the backplates.

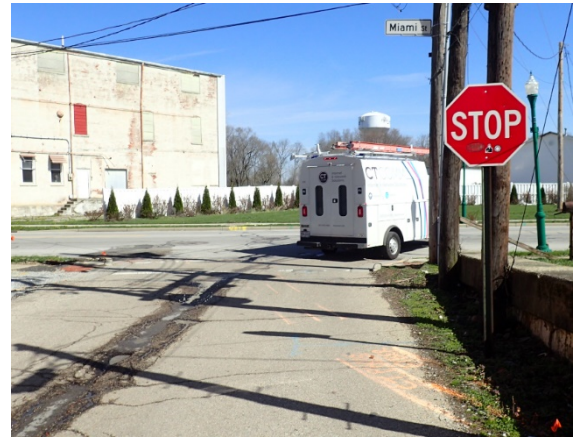
**Photo 6: Stop Sign at Storms Avenue**

- Three westbound rear end collisions occurred at Storms Avenue, likely due to vehicles stopping in the through lane on Miami Street to turn left onto Storms Avenue.
- The current stop sign at the intersection of Storms Avenue and Miami Street is not properly located in relation to Miami Street, shown in **Photo 6**.
- The driveway on the southside of the bike crossing at the Simon Kenton Trail is very wide and the bike path is not delineated, shown in **Photo 7**.
- There were some drainage issues located at the driveway of the Depot Coffee House causing a large amount of standing water, shown in **Photo 8**.
- Stakeholders have indicated that the Depot Coffee House parking lot fills up often and vehicles park along the street.
- A future medical center is being constructed on the south side of this section of Miami Street, which will likely result in increased traffic in the area.

- Move the stop sign at Miami Street and Storms Avenue closer to Miami Street.
- Stripe a bike lane through the driveway at the bike path on the north side of Miami Street near the Depot Coffee House to provide better delineation for bicycle traffic.
- In the future, wayfinding signage can be added at the trail to direct bicyclists to the downtown area.
- Stripe a center TWLTL along this segment to accommodate the number of left-turn vehicles accessing the future medical center development and the existing businesses along this segment. The TWLTL will begin just west of the railroad bridge providing a westbound left-turn lane onto Storms Avenue. With the center TWLTL, on-street parking will be delineated on the north side of Miami Street.

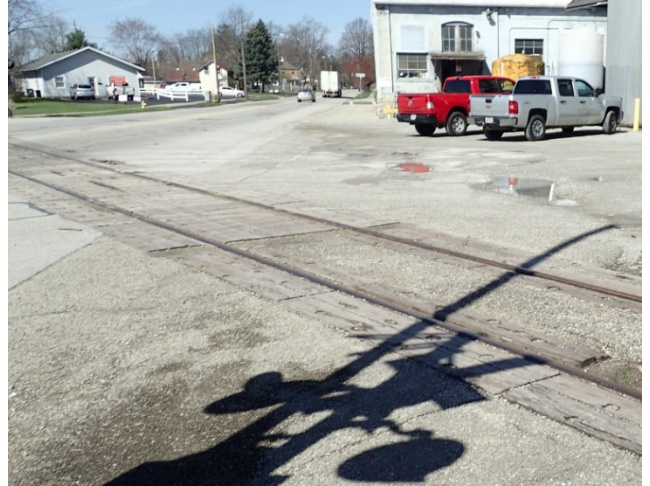
**Photo 9: Wide Pavement at Premier Feeds**

- Sidewalk is not provided on the north side of Miami Street across the large drive of the Premier Feeds business, shown in **Photo 9**.
- While performing the site visit, vehicles from the drive-through were observed queueing out of Crabill's Hamburger Shoppe onto Miami Street in the afternoon.

- Construct the center TWLTL from Storms Avenue, past the railroad tracks, to the entrance of Crabill's Hamburger Shoppe.
- It is recommended that the Premier Feeds driveway be narrowed to improve access management and sidewalk would be constructed across the driveway apron. These improvements would be part of a project separate from the resurfacing and subsequent restriping.

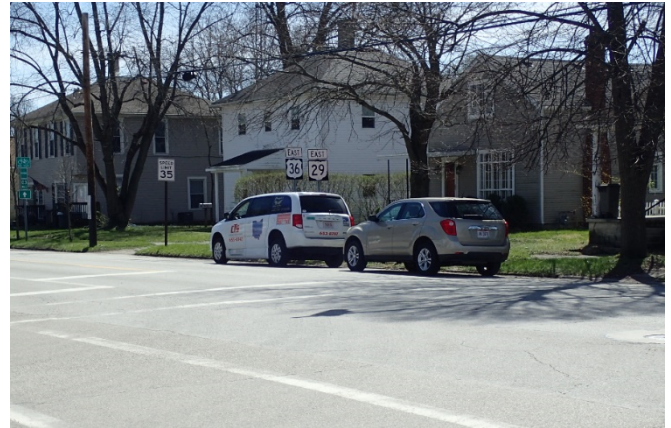
**Photo 10: Vehicles Parked near Oakland Street**

- Stakeholders indicated that truck drivers turning left from N Oakland Street to Miami Street have complained about the parked vehicles on the south side of Miami Street near the intersection, shown in **Photo 10**. The location of the parked vehicles makes it difficult for drivers of large vehicles to make their turning maneuver onto eastbound Miami Street, especially when there is a vehicle stopped at or past the stop bar in the westbound through lane.
  - Two parked vehicle collisions occurred at this intersection.
- Vehicles were observed parking in the westbound right-turn lane, shown in **Photo 11**.
- While performing the field review, it was observed that all the push button covers were missing on the pedestrian push buttons at the intersection, shown in **Photo 12**.

- Repair pedestrian push buttons.
- To accommodate the turning maneuvers for the larger southbound left-turning vehicles at this intersection, the westbound right-turn lane could be removed so that the westbound through lane could be shifted north of the centerline. The on-street parking on the southern side of Miami Street could remain. Based on the traffic volumes provided by the City of Urbana, this exclusive turn lane at this intersection is not warranted.

- A secondary benefit of removing the right-turn lane is that large trucks can make a westbound right-turn onto northbound N Oakland Street easier and faster from the new shared through and right-turn lane than from existing narrow exclusive right-turn lane.
- Add “No Parking” signage between S Oakland Street and N Oakland Street on the south side of Miami Street and between Pappy’s and N Oakland Street on the north side of Miami Street.
