**To:** Louis Agresta  
Clark County-Springfield TCC

February 20, 2024

**From:** Nate Lang, PE  
Burgess & Niple, Inc.

**Subject:** Simon Kenton Shared Use Trail Improvements

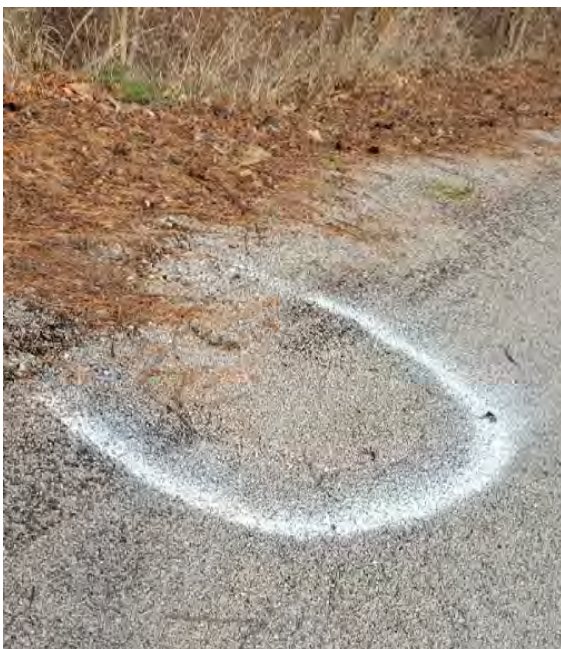
**Photo 1: Typical Edge Deterioration**

The Simon Kenton Trail typically runs parallel to the active railroad, with the cross section of the trail sloping away from the railbed. Edge deterioration was the primary defect observed along the chip sealed trail. Every defect that was found has been marked on the roll plot exhibits in Appendix A and is listed below in Table 1. Most cases of edge deterioration were minor, such as the that shown below in Photo 1. However, significant edge deterioration and erosion was observed at the northern end of the trail, at station 849+00 in the roll plot exhibit and shown below in Photo 2.

"Base" pavement improvements for this project include the asphalt overlay and spot repairs where pavement deterioration was recorded. It is anticipated that the asphalt overlay can be placed directly on to the existing chip seal, including 1.5 inches of intermediate course, 1 inch of 404LVT (low volume traffic) asphalt concrete surface course, and tack coat. At locations where edge deterioration was noted, the existing path will be excavated to a depth of one foot and backfilled with aggregate base. Each pavement repair location identified is assumed to be four feet by four feet, with the major deterioration at station 849+20 assumed to be four feet by fifty feet.

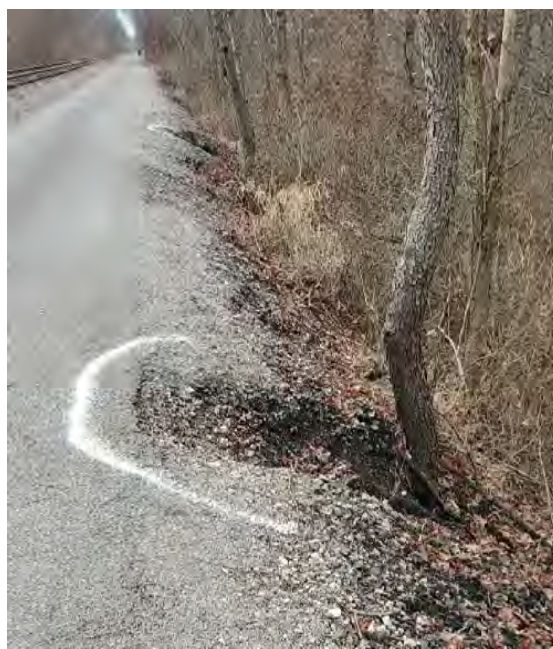
**Photo 2: Major Edge Deterioration at STA. 849+20**

It is anticipated that slope stabilization could be required at the location where major edge deterioration is occurring at station 849+00, the treatment for which is discussed in the Pavement Improvements section of this report. With 55 feet from the edge of the path to the adjacent property, it is anticipated that slope stabilization can be performed without a right-of-way easement.

The significant edge deterioration and erosion at station 849+00 could be addressed by stabilizing the slope on the west side of the trail. It is assumed that most of the trees on the slope can remain. A low-cost solution would involve excavating out the top of the bank and placing gabions and timber guardrail. A more thorough solution would involve placing light rock aggregate on the slope, which would stabilize it without the need for tree removal. The light rock aggregate stabilization solution is included as a supplemental improvement in the cost estimate, and assumes that timber guardrail would be placed at the top of the slope to improve rider safety along this trail segment.

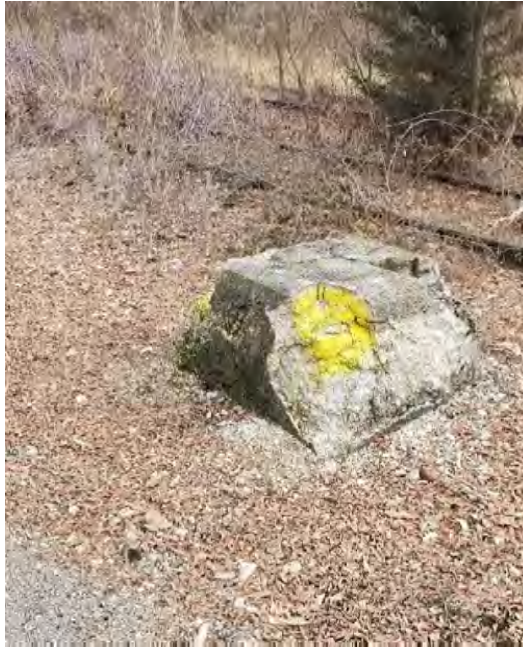
**Photo 3: Concrete Light Pole Foundation**

the trail, which are assumed to be part of the existing railroad infrastructure. There are 6 of these foundations within the study area, like the one shown below in Photo 3.

A supplemental item has been added to the estimate to account for the removal of the concrete pole foundations found along the trail.

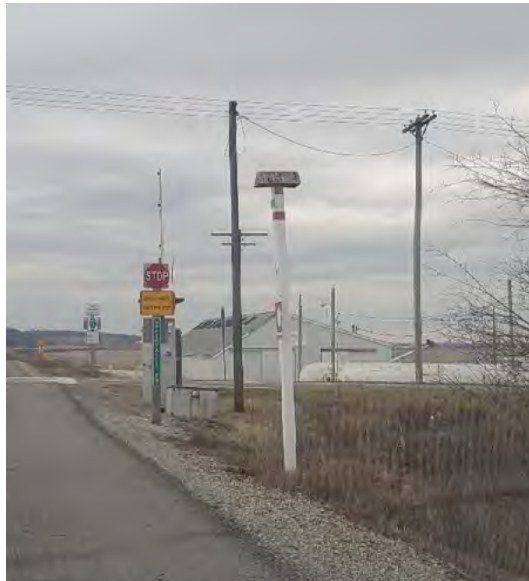
**Photo 4: AT&T Fiber Optic Marker**

There is a major AT&T Fiber Optic (FO) line running parallel with the Simon Kenton Trail within the length of the study area. The FO line is marked with white poles, as shown in Photo 4 below.

Due to the importance of the FO line, its location should be marked using a high SUL quality level before any underground work is done in the study area. It is anticipated that the FO line cannot be relocated, so any of the potential improvements discussed in this study may have to be adjusted to account for the FO line.
