# MEMO

Arcadis Project No.:  
TOHLUC01.ST01

Subject:  
Logan Union Champaign County  
Regional Planning Commission Freight Study

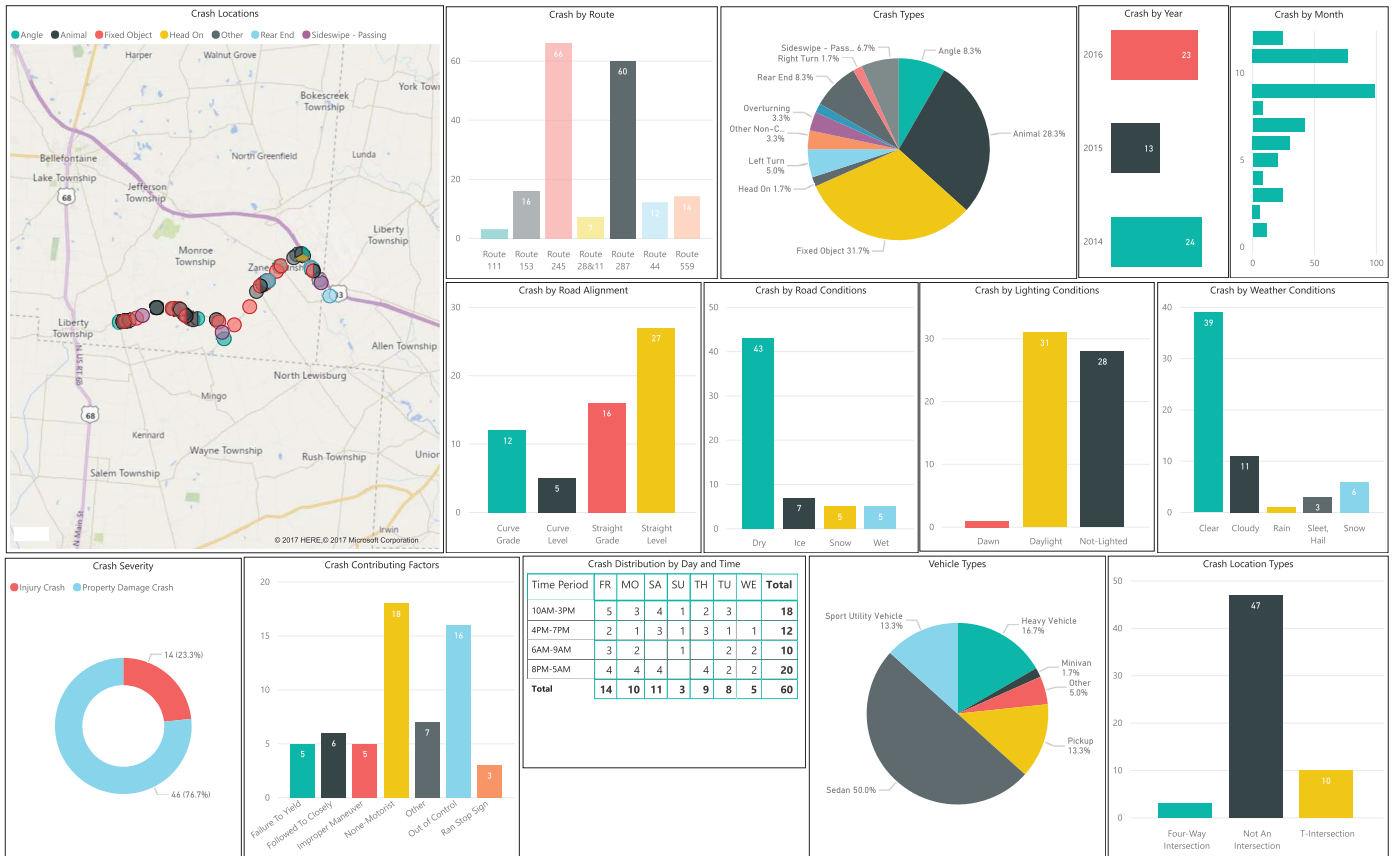
Logan-Union-Champaign Regional Planning Commission - LUC RPC Freight Study - Crash Analysis - Route 287

### State Route 287

A total of 60 crashes occurred on S.R. 287. Fourteen (23 percent) resulted in an injury. Twenty-eight (47 percent) occurred in the dark. Twelve occurred during inclement weather; seven of these occurred on icy pavement and five occurred on wet pavement. Ten (17 percent) crashes involved freight.

Twenty (33 percent) of the crashes were fixed-object crashes. Seventeen (28 percent) were animal strikes, five were angle crashes, and five were rear-end crashes. Four crashes, including one head-on collision, occurred at the intersection with CR 144.

Overall, 62 percent of the crashes on S.R. 287 were fixed-object crashes and animal strikes.

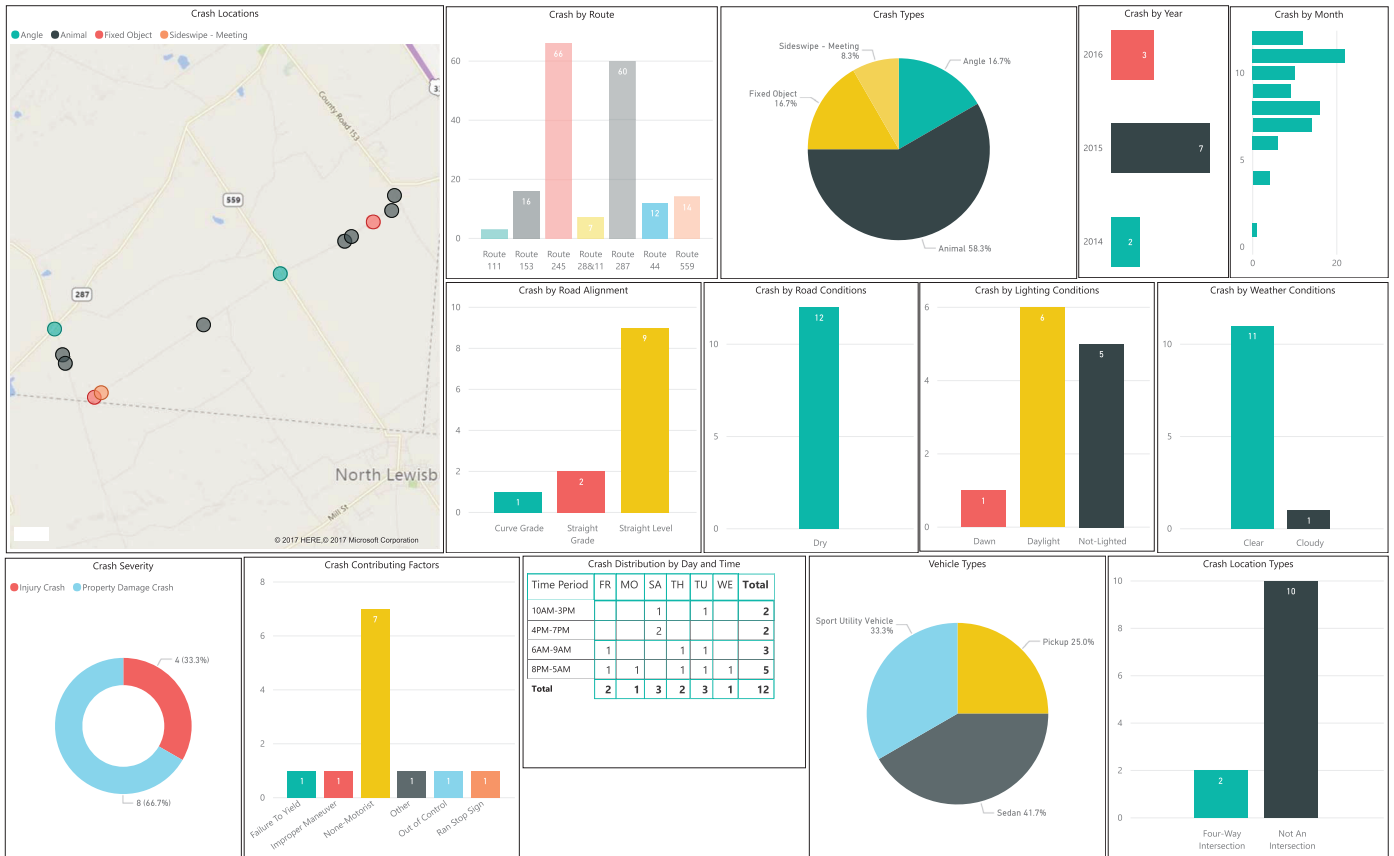
Logan-Union-Champaign Regional Planning Commission - LUC RPC Freight Study - Crash Analysis - Route 44

### Logan County Route 44

A total of 12 crashes occurred on C.R. 44. Four (33 percent) resulted in an injury. Five (42 percent) occurred in the dark. None involved freight.

Seven (58 percent) of the crashes were animal strikes, two (17 percent) were angle crashes, and two were fixed-object crashes. Four of the animal strikes occurred in the dark between S.R. 559 and C.R. 277.

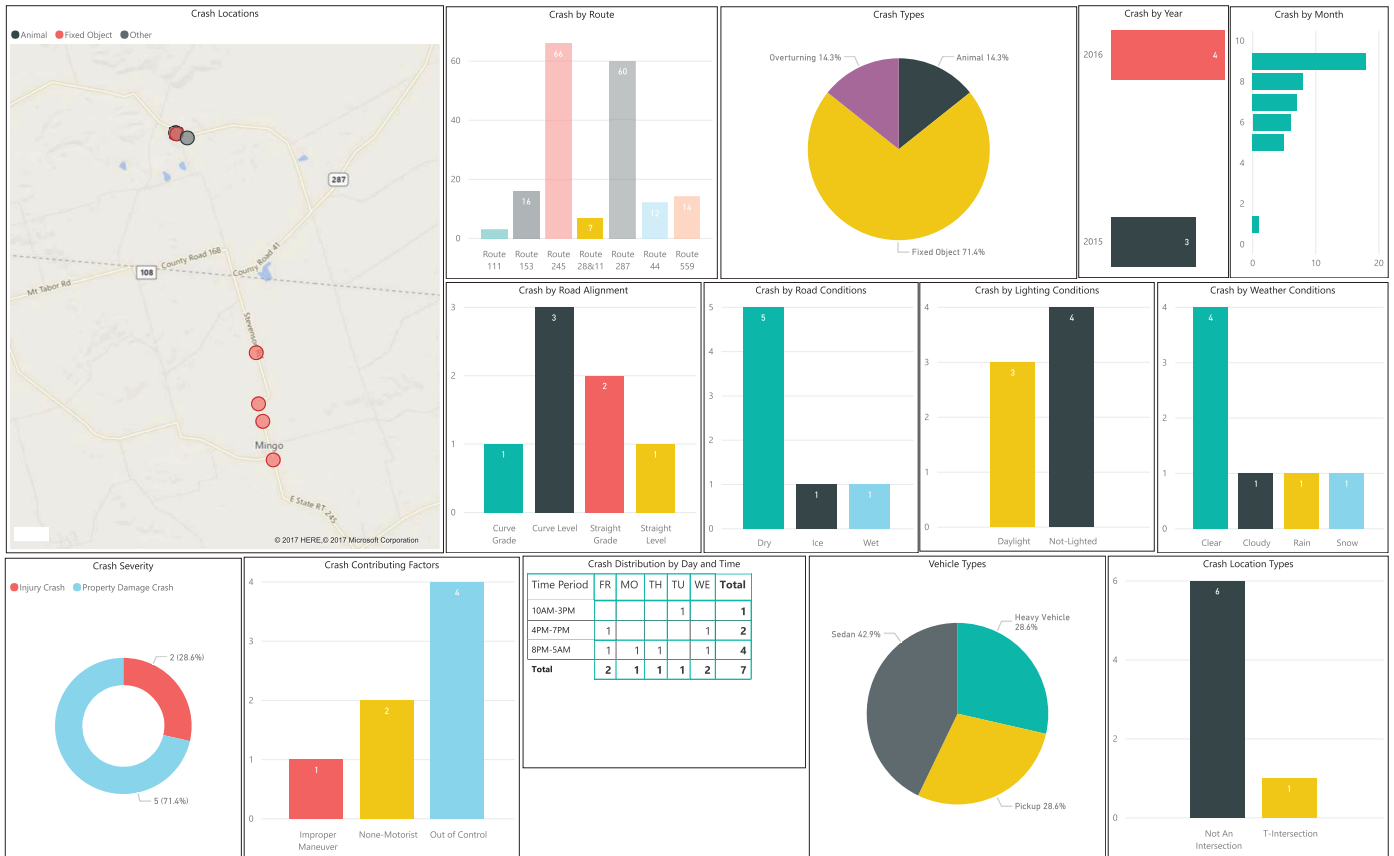
Logan-Union-Champaign Regional Planning Commission - LUC RPC Freight Study - Crash Analysis - Route 28& Route 11

### Champaign County Route 28/Logan County Route 11

A total of seven crashes occurred on C.R. 28/C.R. 11. Two (29 percent) resulted in an injury. Four (57 percent) occurred in the dark. Two occurred during inclement weather; one occurred on icy pavement and one occurred on wet pavement. Two (29 percent) involved freight.

Five (71 percent) of the crashes were fixed-object crashes, four of which occurred between S.R. 245 and Bump Road. One was an animal strike. Four of the seven crashes occurred from 8 p.m. to 5 a.m., and three occurred at the intersection with S.R. 287.

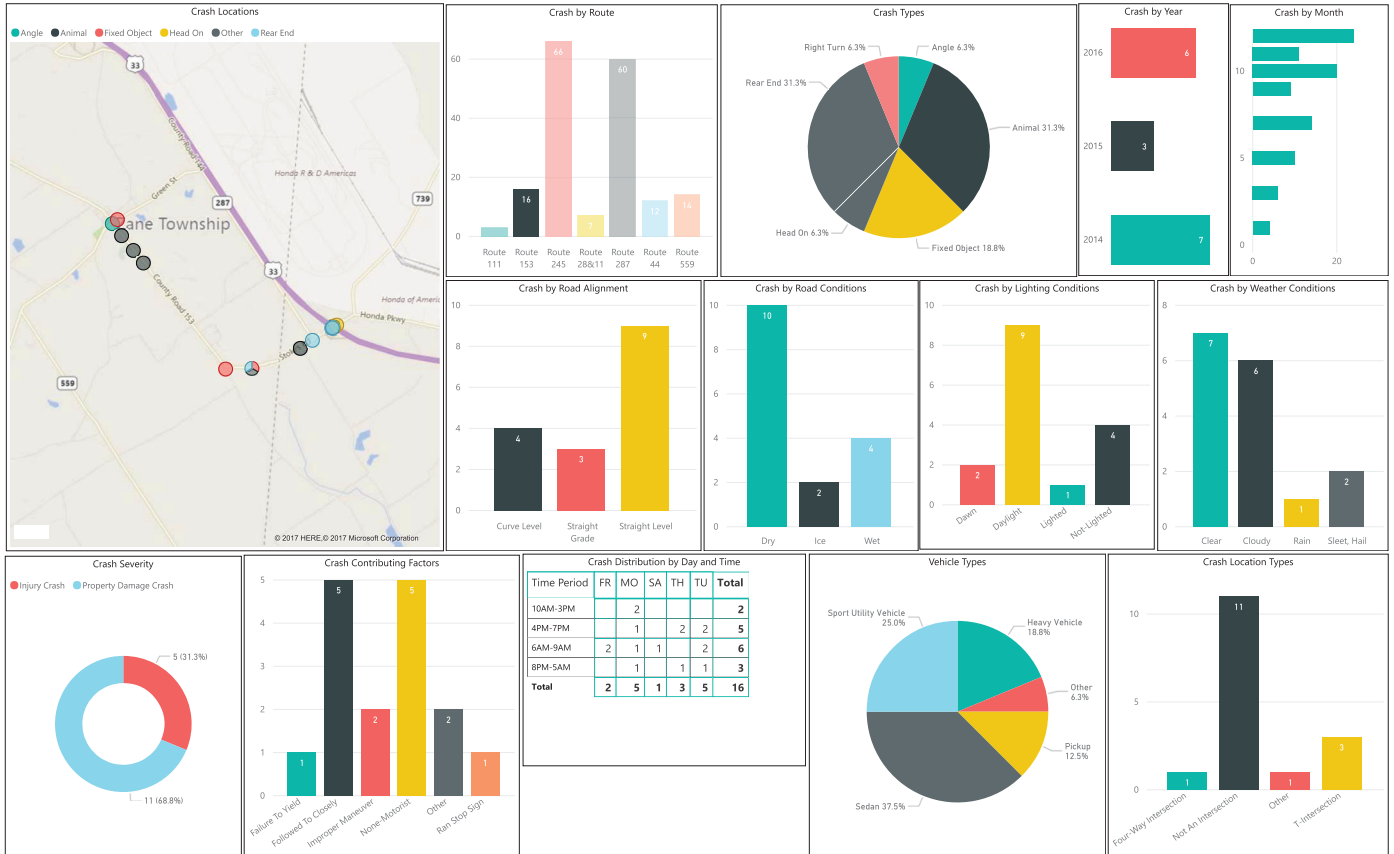
Logan-Union-Champaign Regional Planning Commission - LUC RPC Freight Study - Crash Analysis - Route 153

### Logan County Route 153

A total of 16 crashes occurred on C.R. 153. Five (31 percent) resulted in an injury. Six (38 percent) occurred at dusk or in the dark. Six occurred during inclement weather; two of these occurred on icy pavement and four occurred on wet pavement. Three (18 percent) involved freight.

Five (31 percent) of the crashes were rear-end crashes, five (31 percent) were animal strikes, and three were fixed-object crashes. Four crashes occurred during the a.m. peak hour and four occurred during the p.m. peak hour. Four of the five rear-end crashes occurred between S.R. 287 and C.R. 153. Three crashes occurred east of the Valeo Station, one of which involved freight. Three of the five animal strikes occurred within 3,000 feet of Middleburg.
