Executive Committee Meeting Agenda  
Thursday, November 10, 2022, 1:15 pm

# LUC Regional Planning Commission

Re: Inspection for Repair  
Bridge: CHP-DUGAN-00001  
SFN: 1160044  
Gwynne Street over Dugan Run & IORY RR

Burgess & Niple (B&N) performed an inspection for preliminary repair recommendations and costs of the above referenced bridge on July 6, 2022. The bridge is a four-span structure (**photos 1 and 2**) with spans numbered west to east and consisting of:

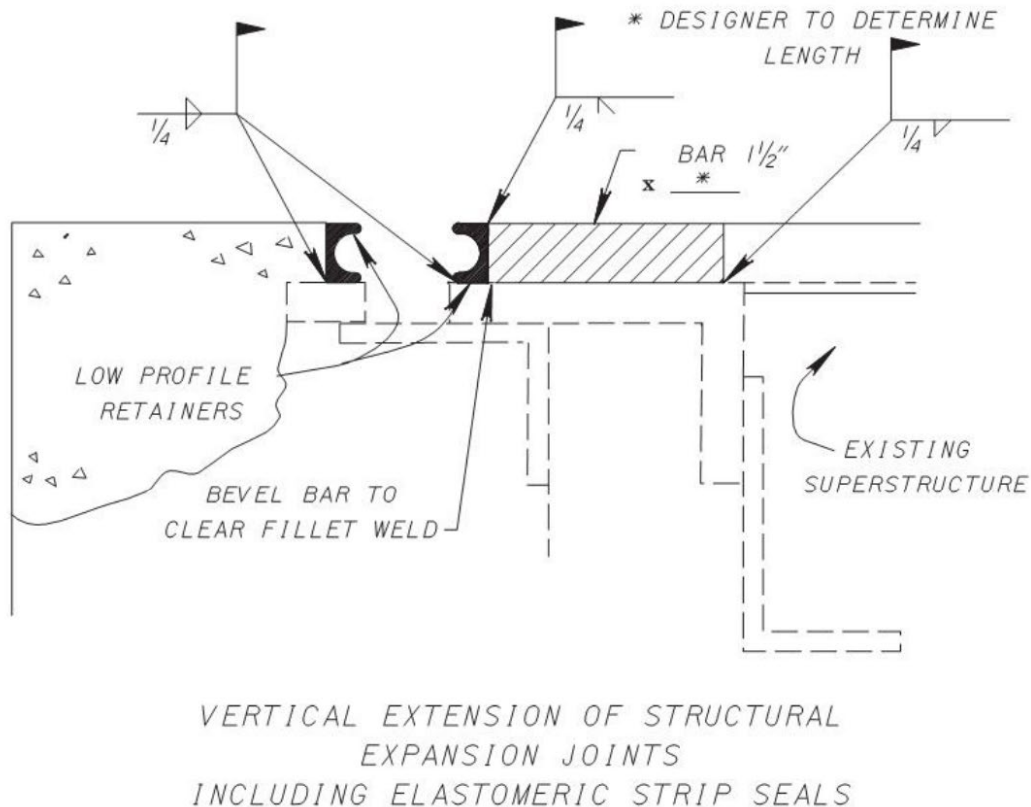
**Figure 403-3**

End Dam (sliding plate expansion joint) – The sliding plate expansion joint devices are leaking and allowing drainage to saturate the concrete substructures and weathering steel superstructure members. A repair that provides a watertight expansion joint device should be

considered. One solution is the repair recommended by the Ohio Department of Transportation (ODOT) Bridge Design Manual (BDM) 403.7.2. This repair should be performed at the existing sliding plate expansion joints at the Rear and Forward Abutments. The repair adds 1 ½ inch thick retainers with elastomeric strip seals, a steel plate and additional overlay material to ramp up to match the new raised strip seal. The repair is illustrated in BDM Figure 403-3 shown below (elastomeric strip seal is not shown but is placed in the retainers).
